**Report on Archaeological Survey of the
Fremantle Prison Women's Prison,
conducted September 2013.**

By Kate Robertson and Alyce Haast

Fremantle Women's Prison Survey | 2013

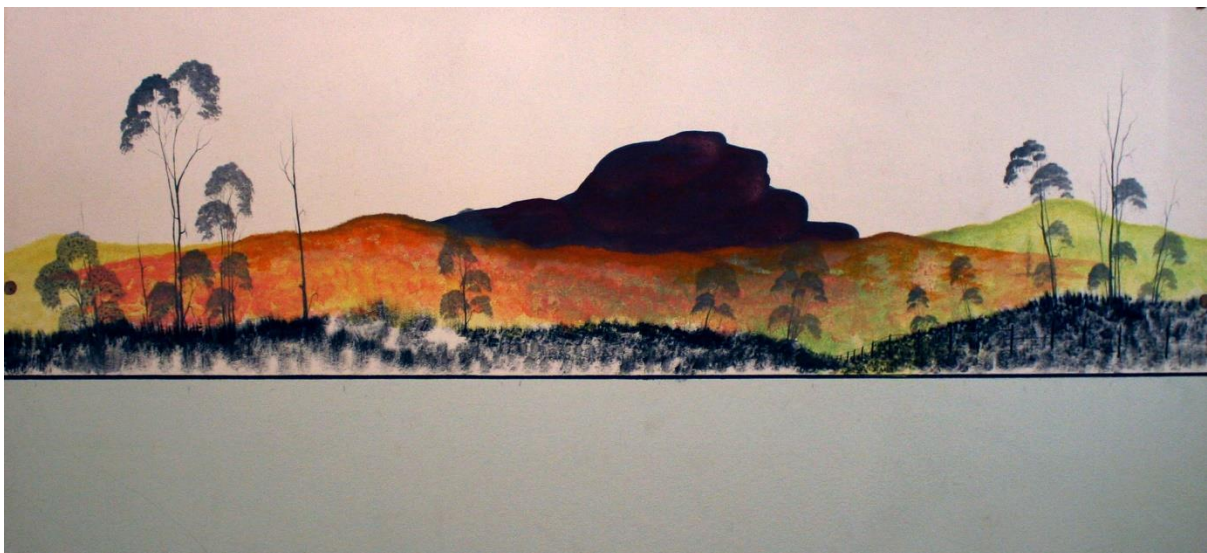
Figure 2: Example of Graffiti within the Prison's Cells

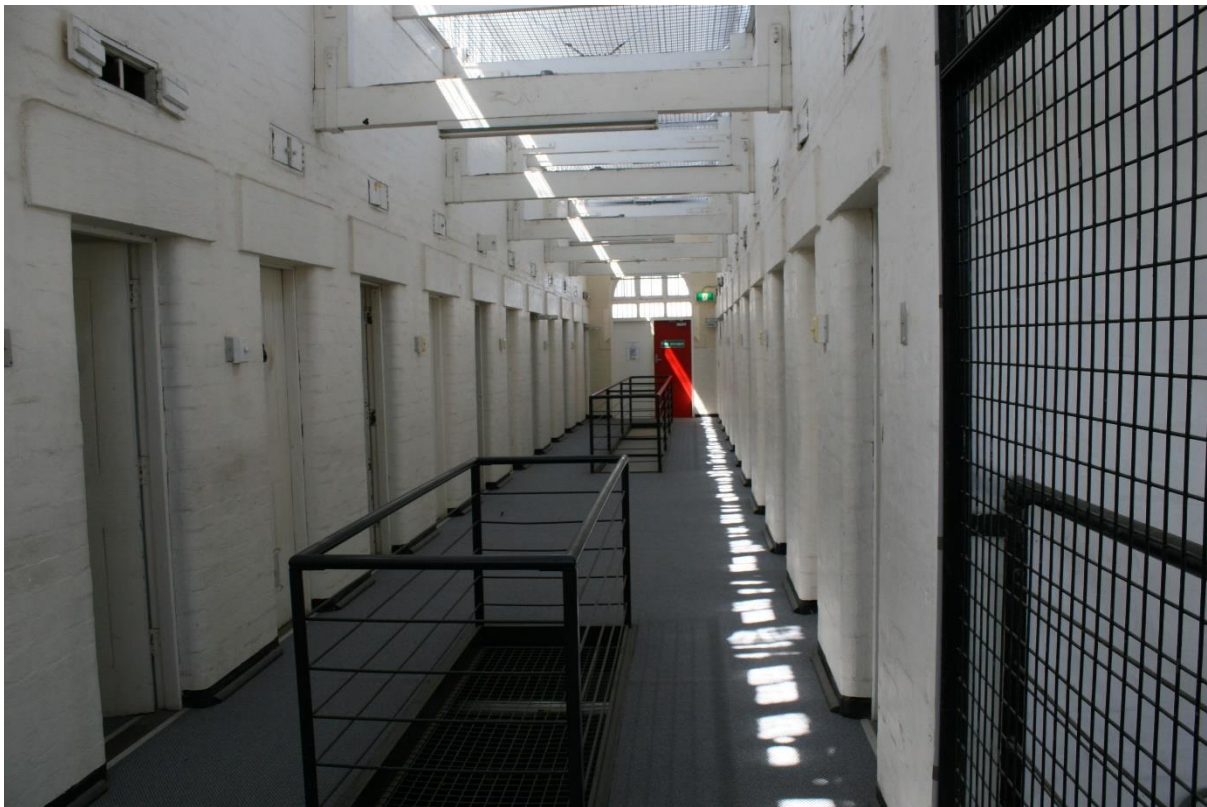
Survey data recorded for 'F Cell blocks' were extremely ambiguous and as such omitted from the archaeological potential analysis. A general observation can be discerned from the data of an overall low significance however this acknowledgement should not be considered an official recommendation for archaeological potential.

Figure 3: Division 3 – the Cells on the Left form the 'F Cell Block' that were excluded in this analysis

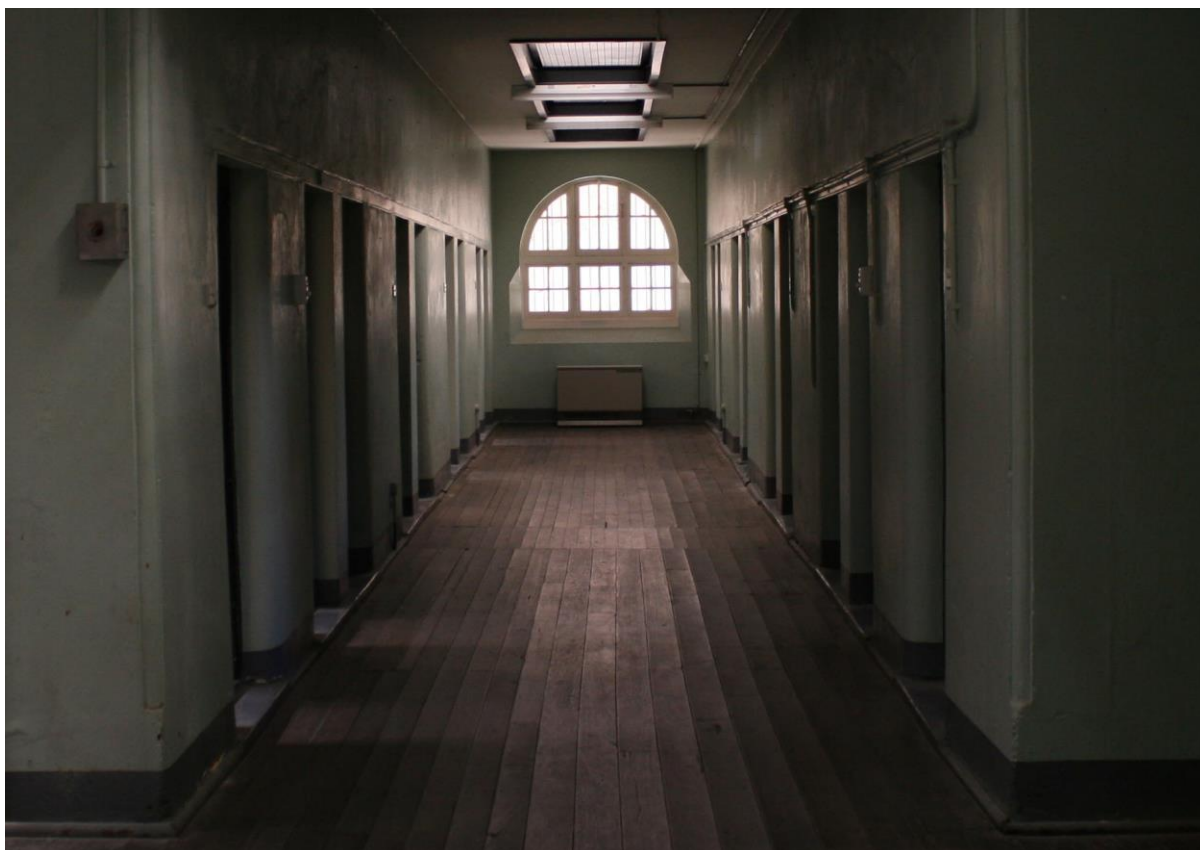
Figure 5: Division 2 Cells

The ground floor of the later construction phase contains the warden's quarters and the Portions of Division 2 cell block. The rooms as such are a combination of cells and office and administration spaces. The administration spaces are dominated by Carpet, Concrete and Linoleum. This is especially prevalent in the matrons quarters in which none of the floor surfaces are timber boards. The combination of low potential for below floor deposits and low graffiti coverage results in these rooms having very low archaeological potential. The cells in this area relating to division 2 consist of portions of original and replaced or repaired boards. The combination of high proportion of repair within the boards and absence of large gaps or holes within the boards limit the archaeological potential of the underfloor deposits in these areas in combination with the low level of graffiti resulting in an overall low archaeological potential for the cells in division 2.

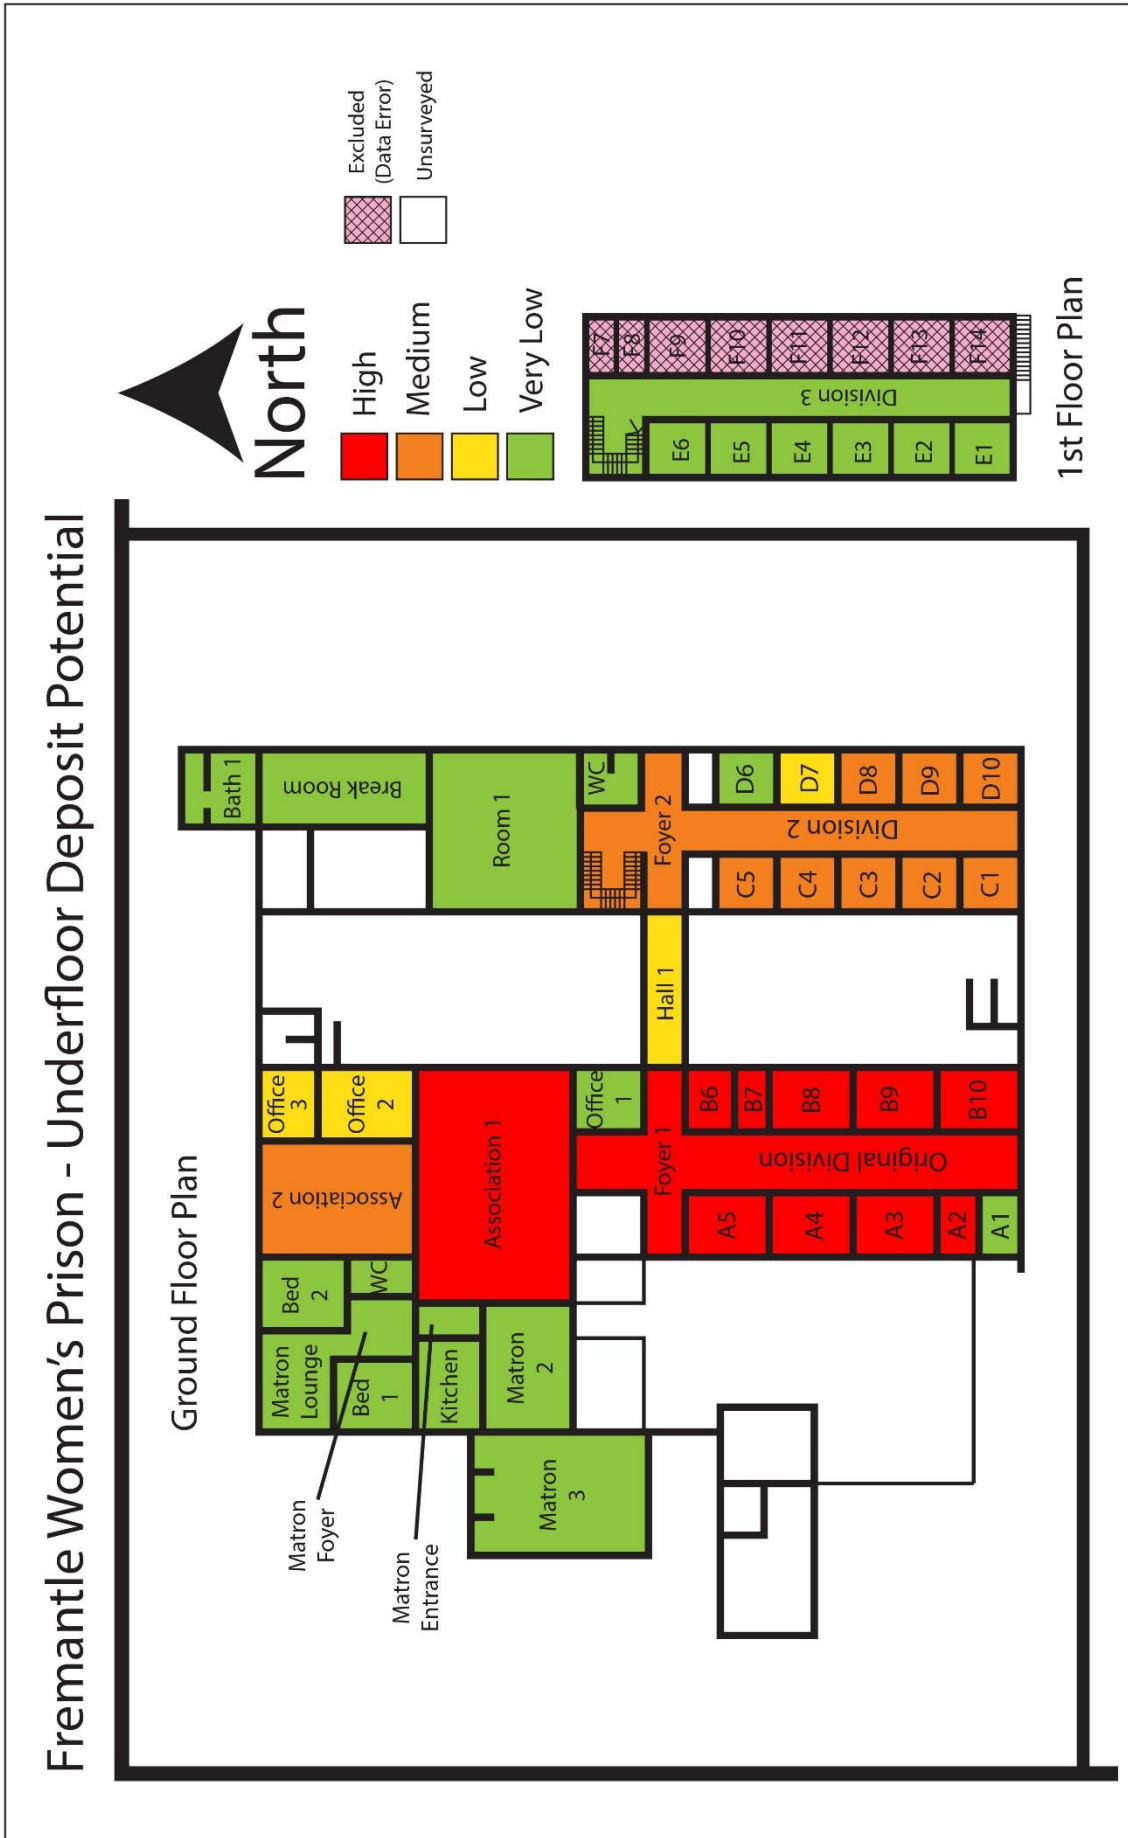
Figure 6: Floor Plan of the Fremantle Women's Prison Complex showing degrees of archaeological potential regarding underfloor deposits.

Areas with the highest archaeological potential for their underfloor deposits are the rooms with the original, intact, floorboards. The most critical of these are designated as high or medium significance floor plan in fig. 6. To maintain the integrity of these areas for future archaeological investigation it is recommended that:

- 1) No floorboards be removed or altered.
- 2) All floors be covered in a manner that preserves the fabric of the original floors and the integrity of the underfloor deposits. For example, carpet laid without being fixed to the boards beneath.
- 3) If any renovation/alteration is to be done in these areas, then the floors must be fully covered and protected.
- 4) If alteration of the original floors is necessary (i.e. for repairs or legal compliance) then surrounding floors should be protected during alteration processes and where possible the underfloor deposits immediately below the area should be maintained as they are.
- 5) Particular attention should be paid to protecting both the floorboards and under floor deposits of the original cell block. These deposits have a high level of integrity and capacity of provide evidence of 19th century occupation

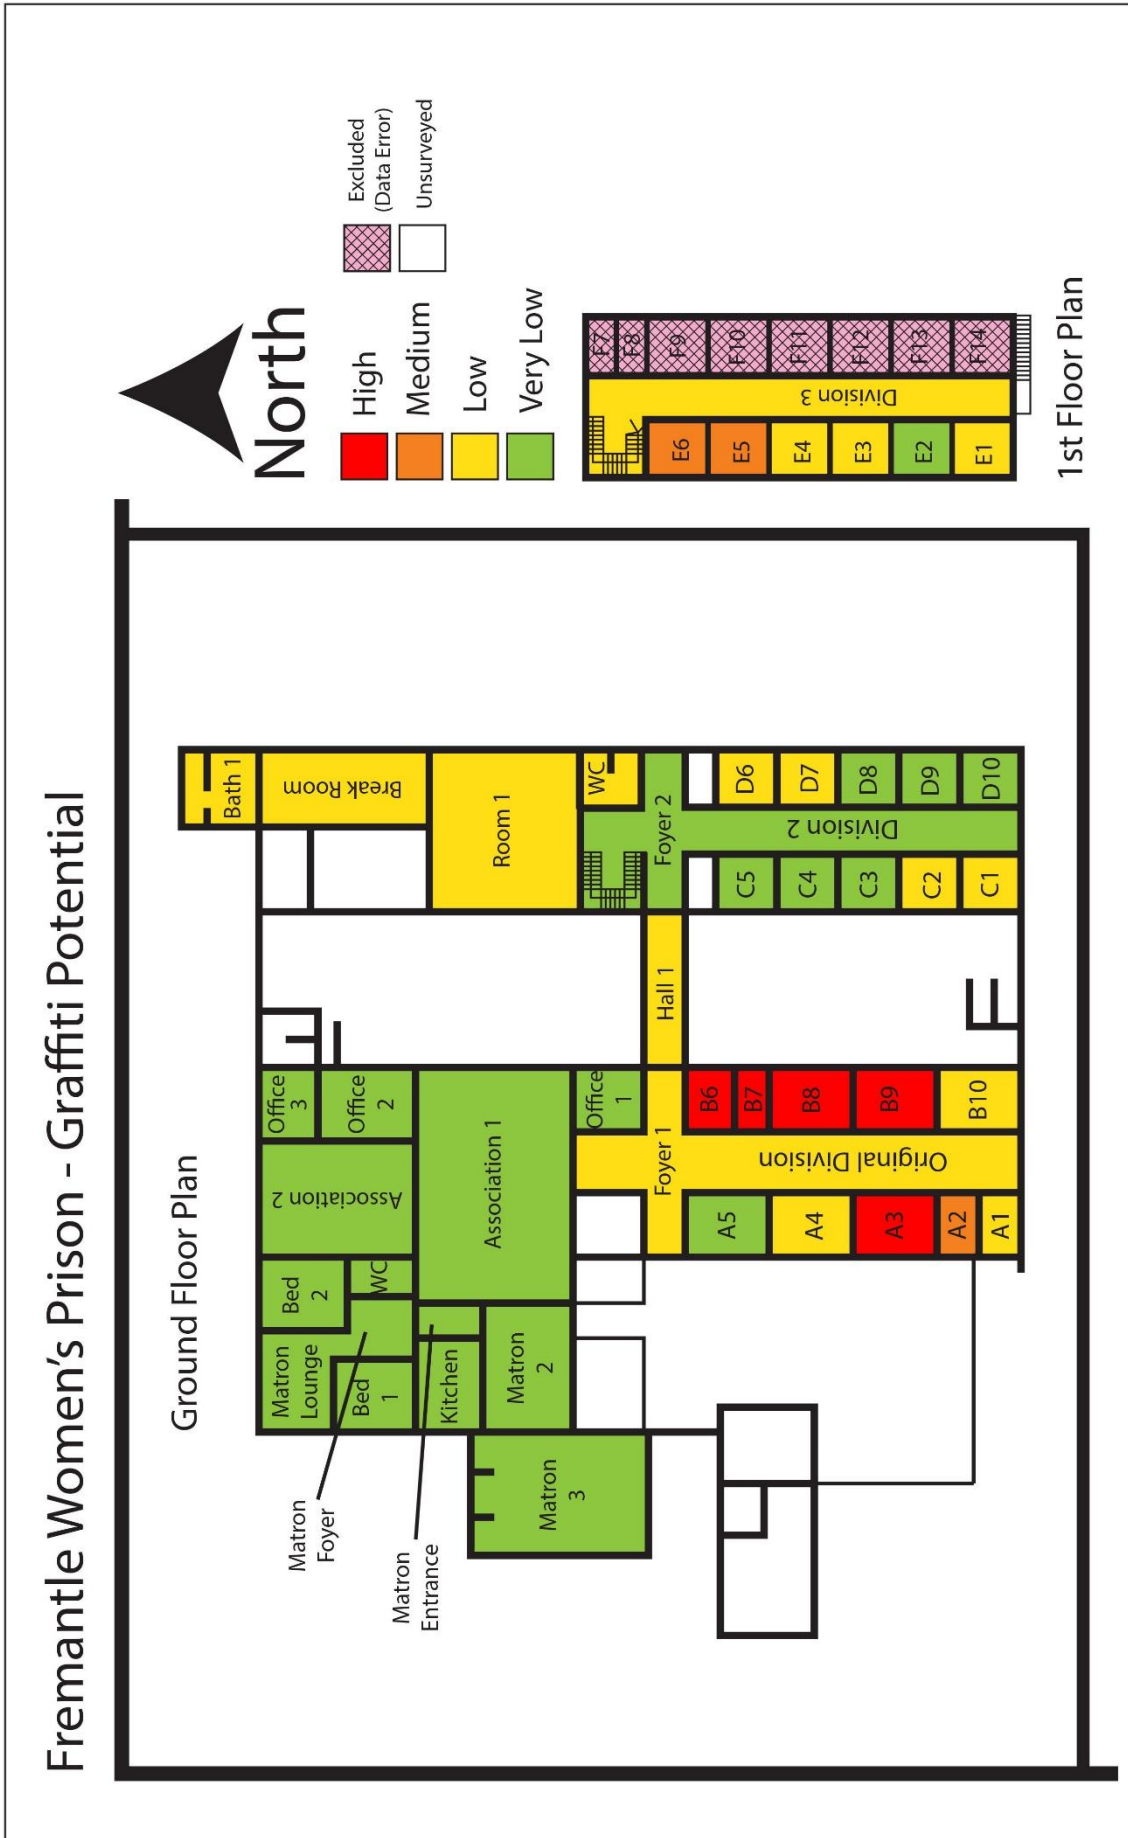
Figure 7: Floor Plan of the Fremantle Women's Prison Complex showing degrees of archaeological potential regarding graffiti.

Initial assessment of the graffiti has shown the wide variety of graffiti types with varying significance. While much of the graffiti within the prison was small and largely insignificant, some graffiti was highlighted within the survey as pertaining specifically to occupation throughout the use of the building as a women's prison and as such highly significant. It is recommended that this Graffiti, specifically the graffiti relating to rooms B7, E5, E2 and F13 be protected if possible. Secondly, it is recommended that a more comprehensive survey be undertaken to fully assess the potential of these items.

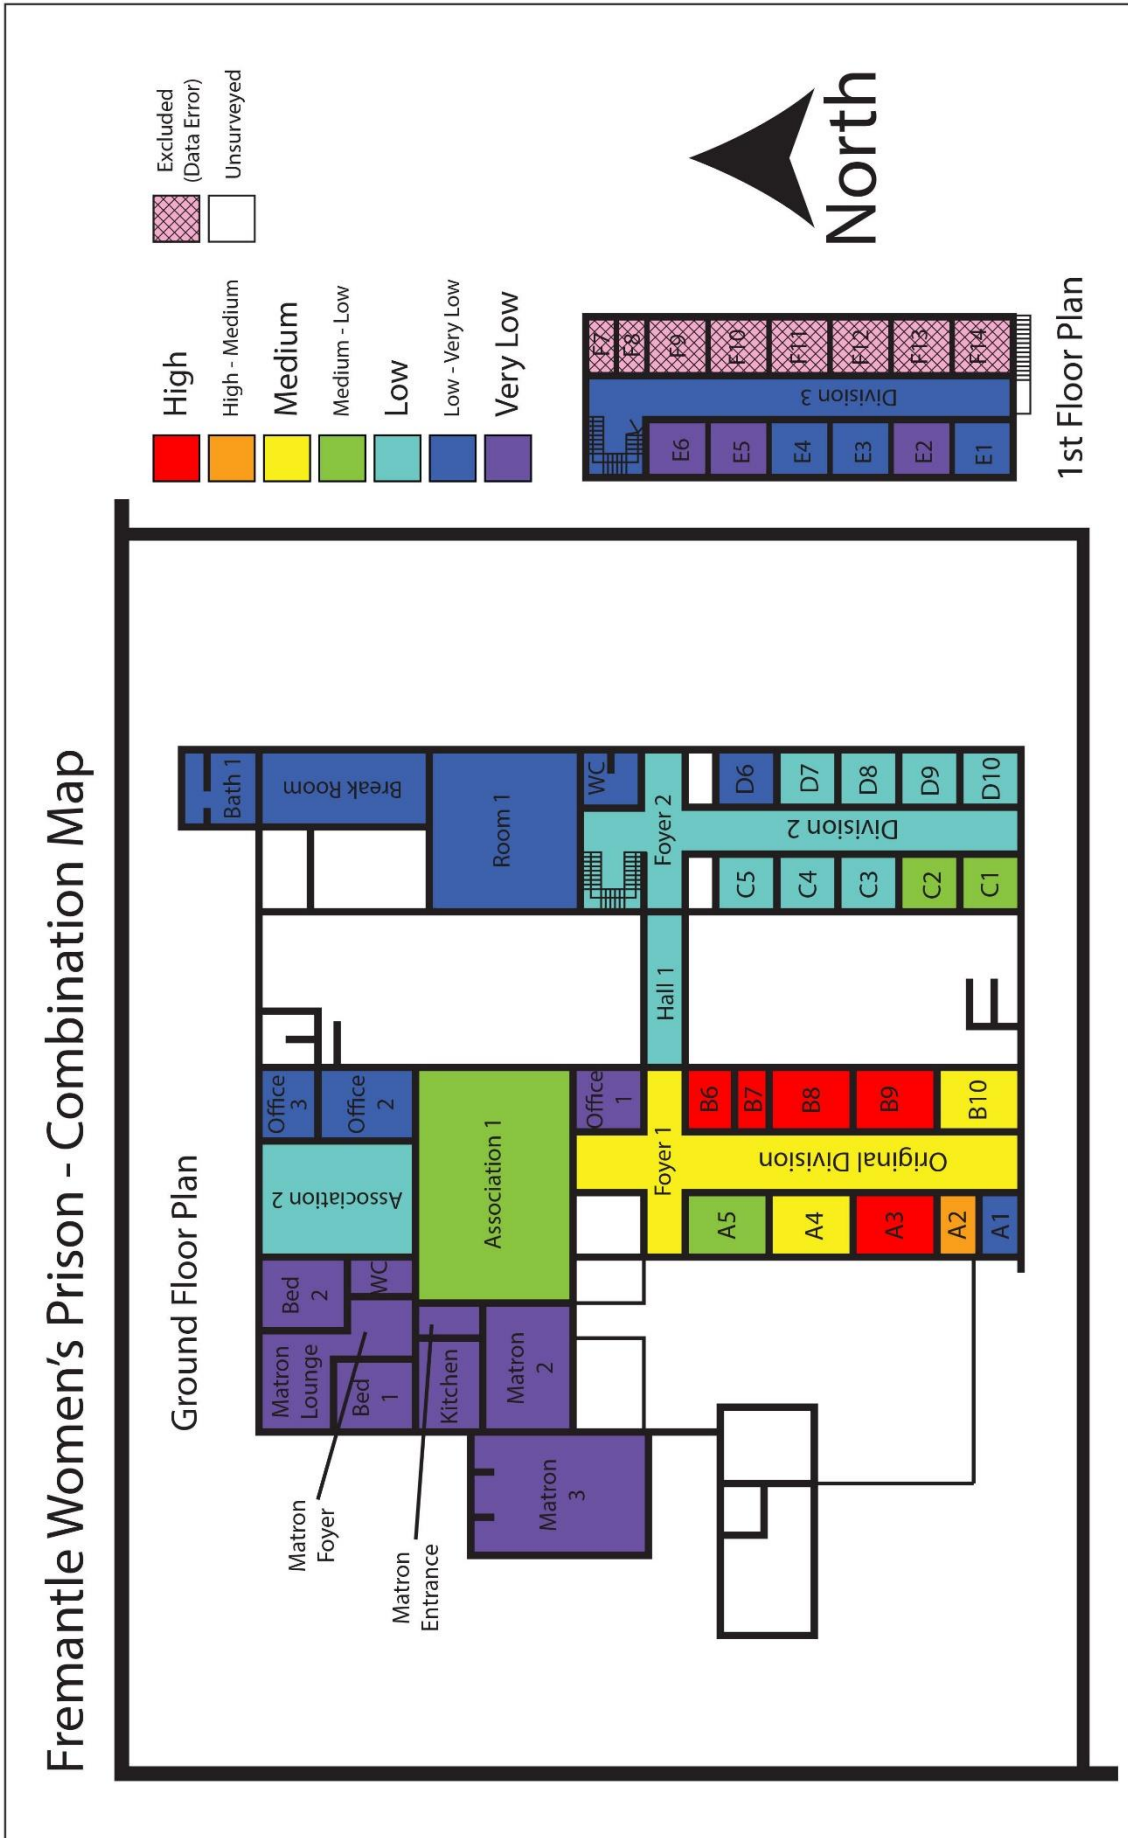
Figure 8: Floor Plan of the Fremantle Women's Prison Complex showing combined (underfloor deposits and graffiti) degrees of archaeological potential.
