# Stone-Working Axe Heads Fabricated by Convicts at an Early Australian Colony

Leonard E. Samuels

Department of Materials Engineering, Monash University, Clayton, Victoria, Australia

The axe heads are thought to have been manufactured before 1857 by transported convicts in a jail at Fremantle, Western Australia, which was then a remote and isolated British colony. They were of a type used to quarry and dress building blocks from a soft, local limestone and had been fabricated by joining on a central plane by forge welding two plates of puddled wrought iron, a central region being left unwelded to form a shaft hole. A section of crucible steel was then inset into the bit edge, also by forge welding (a process known as "steeling"). This procedure obviously required a high level of blacksmithing skill, and at least a reasonable level of skill had been achieved at the Fremantle jail. However, a number of fabrication abnormalities were present in the axe heads, drawing attention to some intrinsic deficiencies in the fabrication procedure. Examples are the difficulties of achieving weld bonding in regions adjacent to the shaft hole and that of avoiding "burning" in both wrought iron a

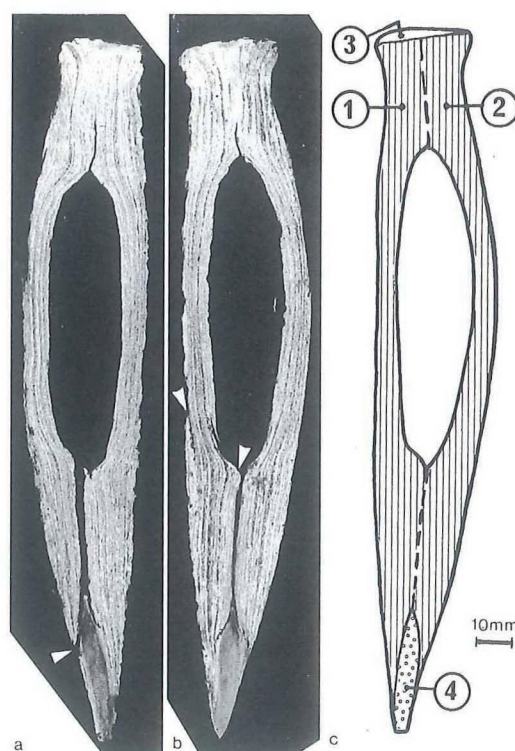
FIG. 2. Etched sections of the unused axe head. The two sections, (a) and (b), were cut 25mm apart at about the midwidth of the blade. The four units from which the axe head was fabricated are identified in (c). Note the asymmetric cross section of the head and the discontinuities extending from both the crown and the root of the shaft hole. The discontinuity in the blade extends to one of the blade surfaces at the position identified by the arrow in (a). The grain flow in the region identified by the arrow at the root of the shaft hole in (b) indicates that the two plates from which the blade was fabricated had not been brought into contact at this position. The other arrow in (b) points to a small surface forging fold. Etched in 10% aqueous nitric acid.

The head had been fabricated by forge welding together four pieces of iron or steel (Fig. 2). These pieces were: two plates of puddled wrought iron [labeled 1 and 2 in Fig. 2(c)] joined above and below the eye

(shaft hole) to form the blade and poll, respectively; a strip of iron [labeled 3 in Fig. 2(c)] welded to the back surface of the poll; and a strip of steel [labeled 4 in Fig. 2(c); see also Fig. 3] inset into the bit at the working edge.

arrow in Fig. 2(b)], but otherwise the grain flow smoothly follows the external contour of the head. The discontinuity visible on the end faces of the blade begins at the root of the eye [Fig. 1(a)] and extends along the full length of the eye. It extends along the central joint plane toward the bit insert, where it bifurcates to follow the contour of the insert [Fig. 2(a)] along a plane slightly removed from the insert-blade interface (Fig. 3). For about half the bit length, the discontinuity then extends to the blade surface on one side [Figs. 2(a) and 3(b)]. The discontinuity at the midplane contains a considerable amount of a layered corrosion product (rust) but also contains extensive patches of a nonmetallic material with a duplex structure (Fig. 5). This material clearly was welding slag that had not been expelled from the weld plane, as would be necessary to achieve metal-to-metal bonding.<sup>†</sup> Moreover, the forging grain flow at the root of the eye indicates that the surfaces of the two blade plates had not been brought into contact in this region [Fig. 2(b)].

A discontinuity was also present along the weld plane at the poll side of the shaft hole eye [Fig. 2(a)]. This discontinuity extended from the root of the eye for up to half the depth of the poll [Fig. 2(a, b)] and was largely filled with a material that had a duplex structure similar to that illustrated in Fig. 5. Layered corrosion products were also present. This discontinuity can again be attributed to failure to bring the two surfaces into intimate contact when welding was being attempted.

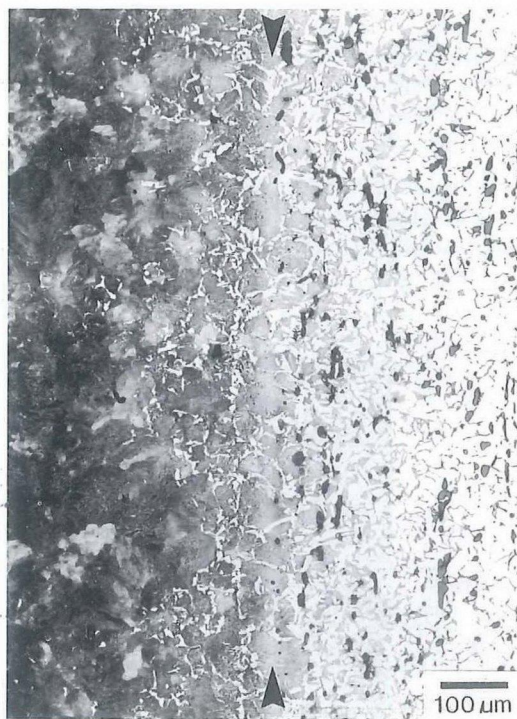
FIG. 8. Section of the forge weld between the wrought iron (right) and the steel insert (left) at the bit of the unused axe. The weld line is indicated by the light-etching band (arrows). Good bonding was achieved along the weld and diffusion of carbon occurred across the weld plane from the steel into the wrought iron. Note that the inclusions in the wrought iron adjacent to the weld are much smaller than those remote from the weld [cf. Fig. 3(b)] because the original inclusions were fragmented by the strains imposed during welding. Light micrograph; etched in 2% nital.

A fully bonded weld had been achieved completely around the insert (Figs. 3 and 8). Diffusion of carbon had occurred across the weld plane, resulting in carburization of the adjacent wrought iron and decarburization of the steel, each to a depth of 125 $\mu$ m (Fig. 8). This diffusion is characteristic of forge welding because the weld regions remain at high temperatures for a lengthy period of time. The austenitic grain size in the diffusion zone was small (50 $\mu$ m average grain diameter). Large nonmetallic inclusions in the wrought iron immediately adjacent to the weld plane had been fractured into small segments (Fig. 8), another characteristic of forge welds.

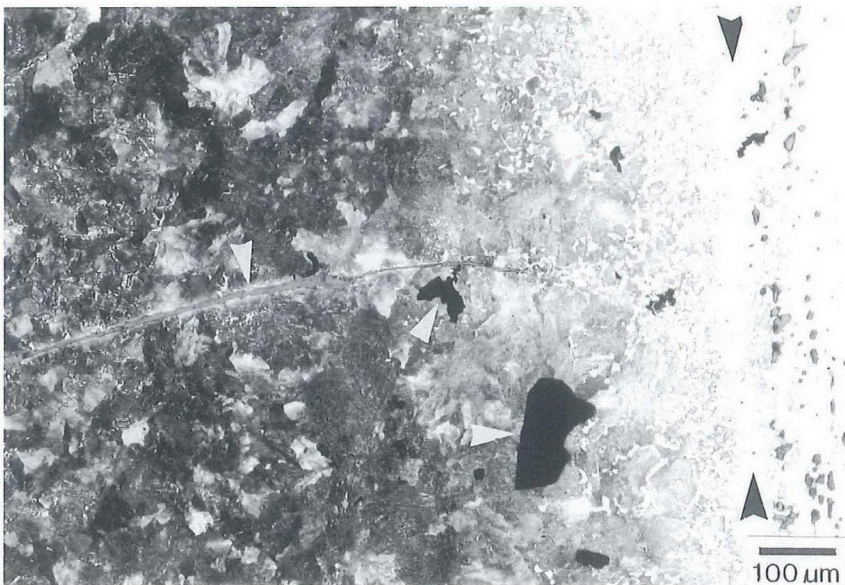
FIG. 10. Microstructure of the crown region (identified by an arrow in Fig. 3) of the insert in the unused axe. The crack and cavities indicated by the white arrows are the result of partial grain boundary liquation during welding. The weld line is indicated by the black arrows. Light micrograph; etched in 2% nital.

A noteworthy feature of the insert was that partial grain boundary liquation had occurred in a localized region remote from the bit edge (Fig. 3). In modern terminology [9], the steel had been *burnt* in this region during heating for forging. As a result, networks of oxide-filled cracks and occasional cavities are present (Fig. 10). These liquation structures establish the locations of the austenitic grain boundaries at the time of forge welding the insert and so establish that the austenitic grain size of the insert steel immediately after forging was about 1mm. This is considerably larger than that currently existing (about 50 $\mu$ m), from which it can be deduced that the axe head must have been subjected to a grain-refining heat

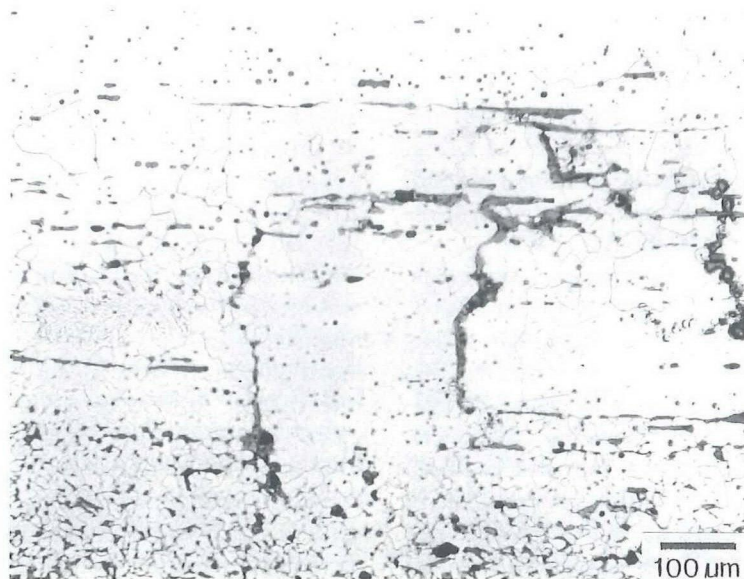
FIG. 11. Microstructure of a region in the wrought iron blade of the unused axe adjacent to the weld to the bit insert and close to the area at which partial liquation had occurred in the insert. Nonmetallic inclusions in the wrought iron appear to have melted and penetrated along the austenitic grain boundaries that existed in the iron at the time. Light micrograph, etched in 2% nital.

An unusual structure is also present in the wrought iron in a region adjacent to the one in which burning occurred in the bit steel. The nonmetallic inclusions in the iron were relocated in a network around what can be presumed to have been the austenitic grain boundaries that existed at the time and temperature of forging (Fig. 11). It seems that the inclusions melted, penetrated along the boundaries while molten, and then subsequently solidified at these boundaries. This structure can also be taken to indicate that an undesirably high temperature was attained locally during the insetting operation. This structure indicates

that the grain size at the forging temperature was considerably larger than that from which the current microstructure was generated, again indicating that the material had been subjected to a grain-refining heat treatment after forging.
