**REPORT OF ARCHAEOLOGICAL
INVESTIGATIONS ASSOCIATED
WITH THE FREMANTLE PRISON CELL
RECONSTRUCTION PROJECT**

Prepared by
Gaye Nayton B Sc (Hons) AACAI
For
The Department of Contract and Management Services
and
The Fremantle Prison Trust
1998

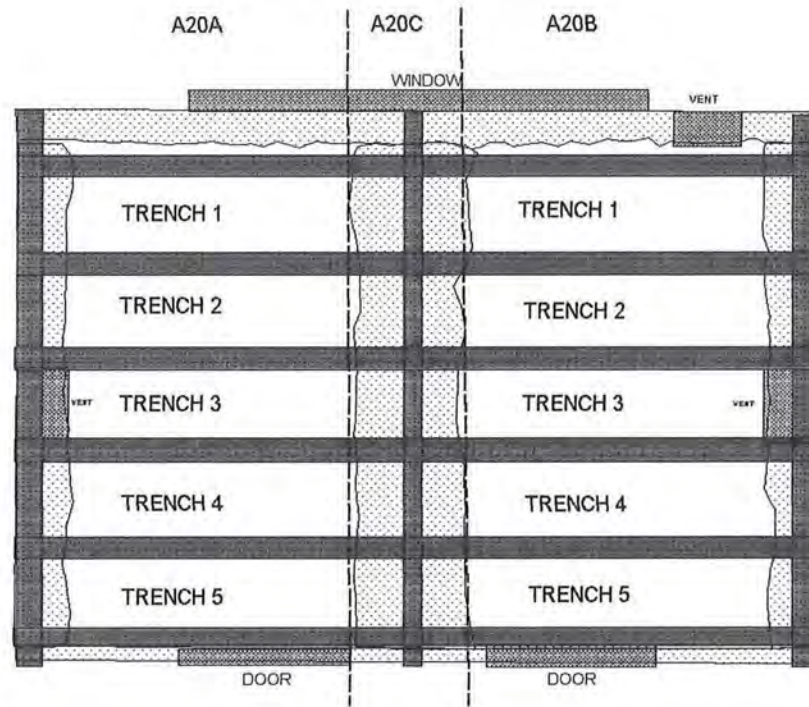
Excavation of the under floor deposits in cell A20 was carried out between the 27 march and the 8th April 1997. The cell was divided into three sections for excavation. Section A (A20a) being the left hand side of the cell between the southern wall and the remains of a parallel demolished wall running across the centre of the cell (part of cell to be returned to 1850s condition). Section B (A20b) being the right hand side of the cell between the northern wall and the central demolished wall (part of the cell to be returned to 1860s condition). Section C (A20c) was the central area covered by the remains of the demolished wall (to be reinstated). Each section was excavated in five trenches located between the joists. They were orientated north south and demarked by the presence of a joist timber on the east and west (Fig 2).

FIG 2. PLAN OF EXCAVATION TRENCHES

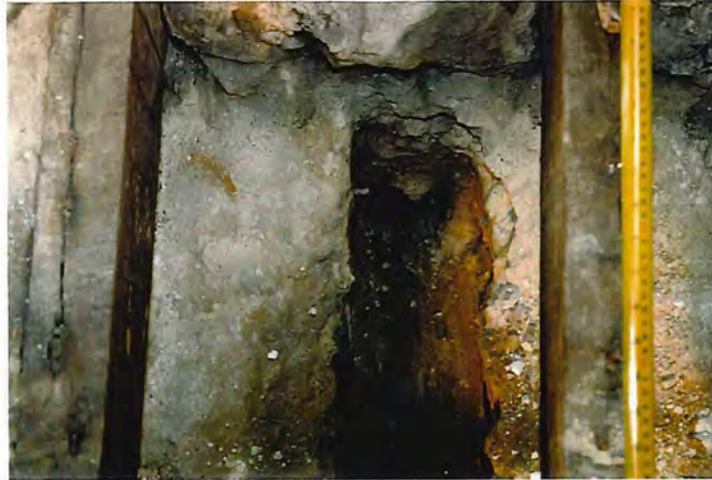
Plate 2. Cell drain fully excavated

A 10cm diameter channel, cut through the limestone wall for the continuation of the drain, was discovered through both the north and south cell walls at a depth of 57cm below floor height (Plate 2). The channel was clear for the approximate distance of the limestone walls but was blocked beyond it. At the same depth a dark deposit of sediment containing artifacts was found which denoted the location of the bottom of the drain. This deposit was not on a noticeably gradient. Whilst the channel was found in both the north and south walls, a similar opening was not convincingly displayed through the demolished cell wall. After discussions with Alan Kelsall a hypothesis was formulated suggesting that the cell floor drain was formed in short sections each of which serviced two cells then fed through the corridor wall to a corridor drain found running parallel with the cells when the corridor concrete was lifted. If this hypothesis is correct then cell A20 contains the left and right hand parts of two different drain sections. Neither showed evidence of a connection through to the corridor therefore if the hypothesis is correct the corridor connection lies inside the limestone walls. This possibility could not be pursued during the course of this project.

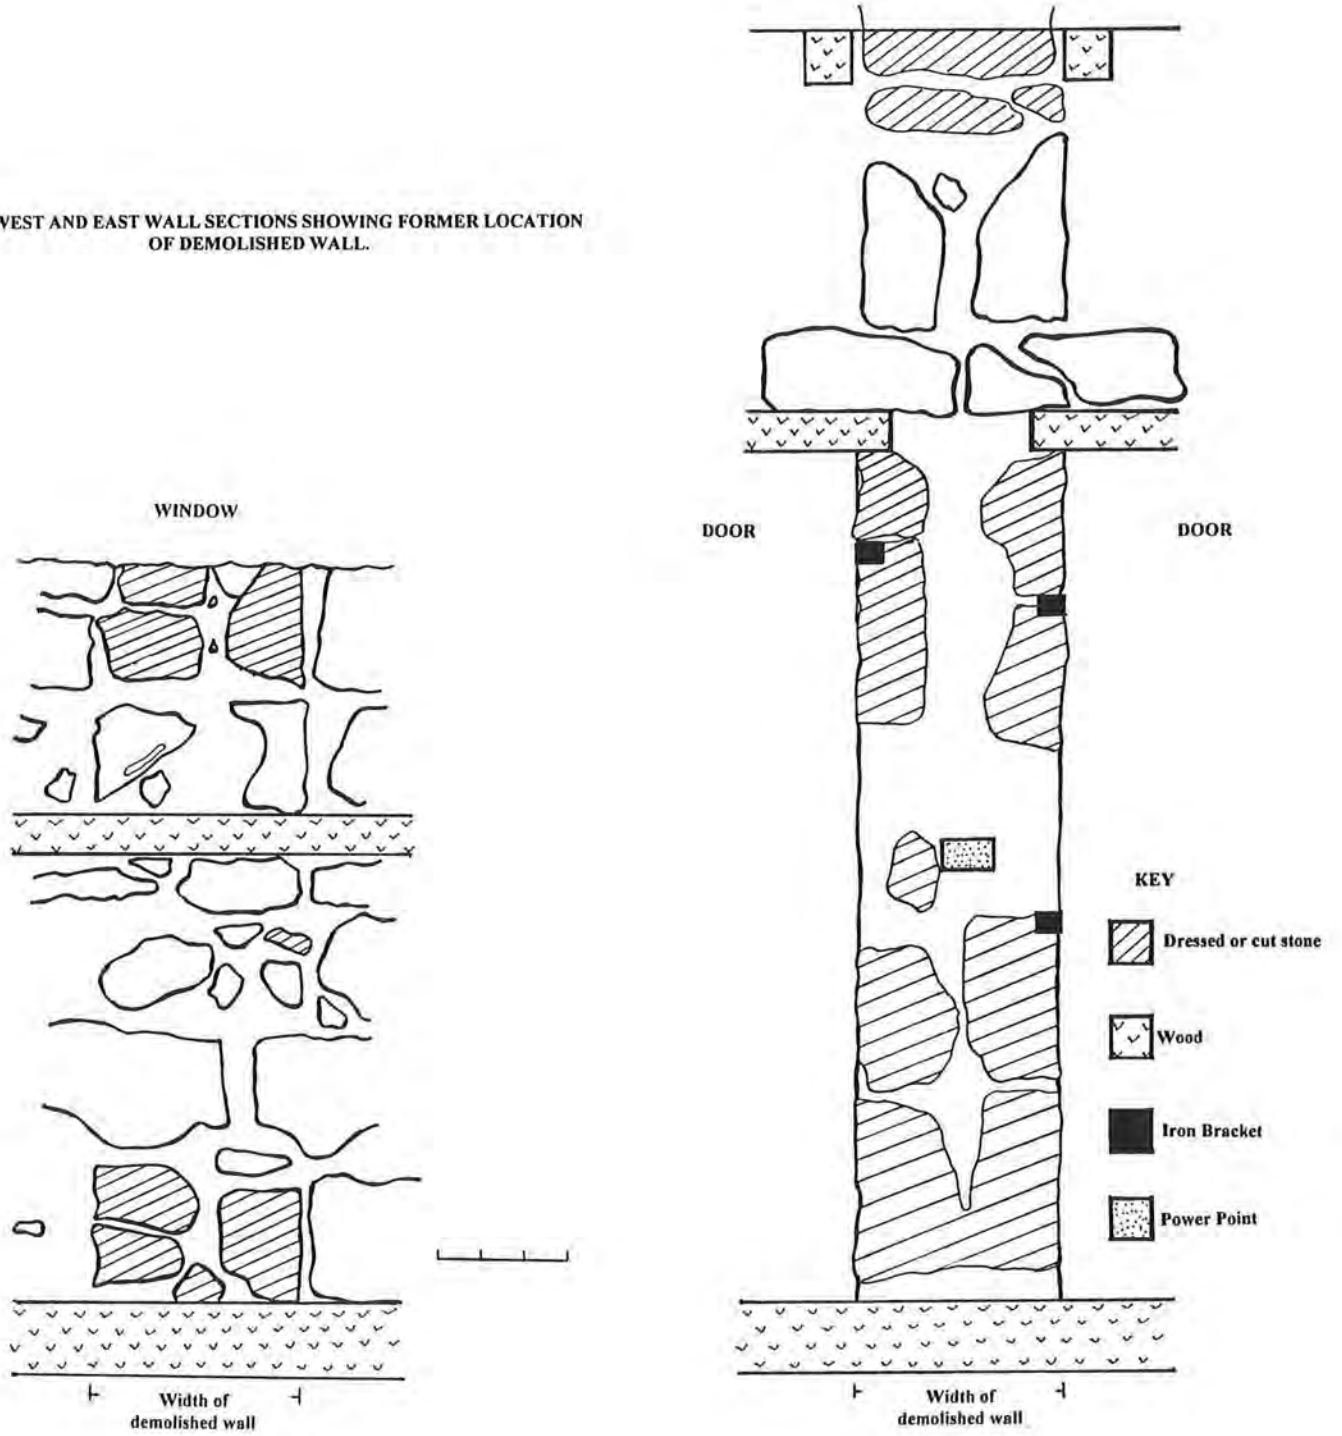
Once the vents had been formed the cell walls were then built around and over the joists. The walls are of limestone much of which was only very roughly dressed. The demolished east west wall offers further clues on how the east west oriented walls were keyed into the walls running north south. The areas where the wall abutted the east and west wall of the cell contains both dressed and undressed stone. While the dressed stone may have been cut prior to being built into the wall it is more likely that they were the stones keying the three walls together and were cut through when the missing wall was demolished. The noticeable grouping of the cut stones reinforces this interpretation (Fig 3). On this evidence the walls appear to be more firmly keyed into the eastern (corridor) wall than to the external wall. Cut stones appear only at the bottom of the west wall and under and above the window, while on the east wall all the visible stones are cut to above the door lintel.

FIG 3. WEST AND EAST WALL SECTIONS SHOWING FORMER LOCATION OF DEMOLISHED WALL.

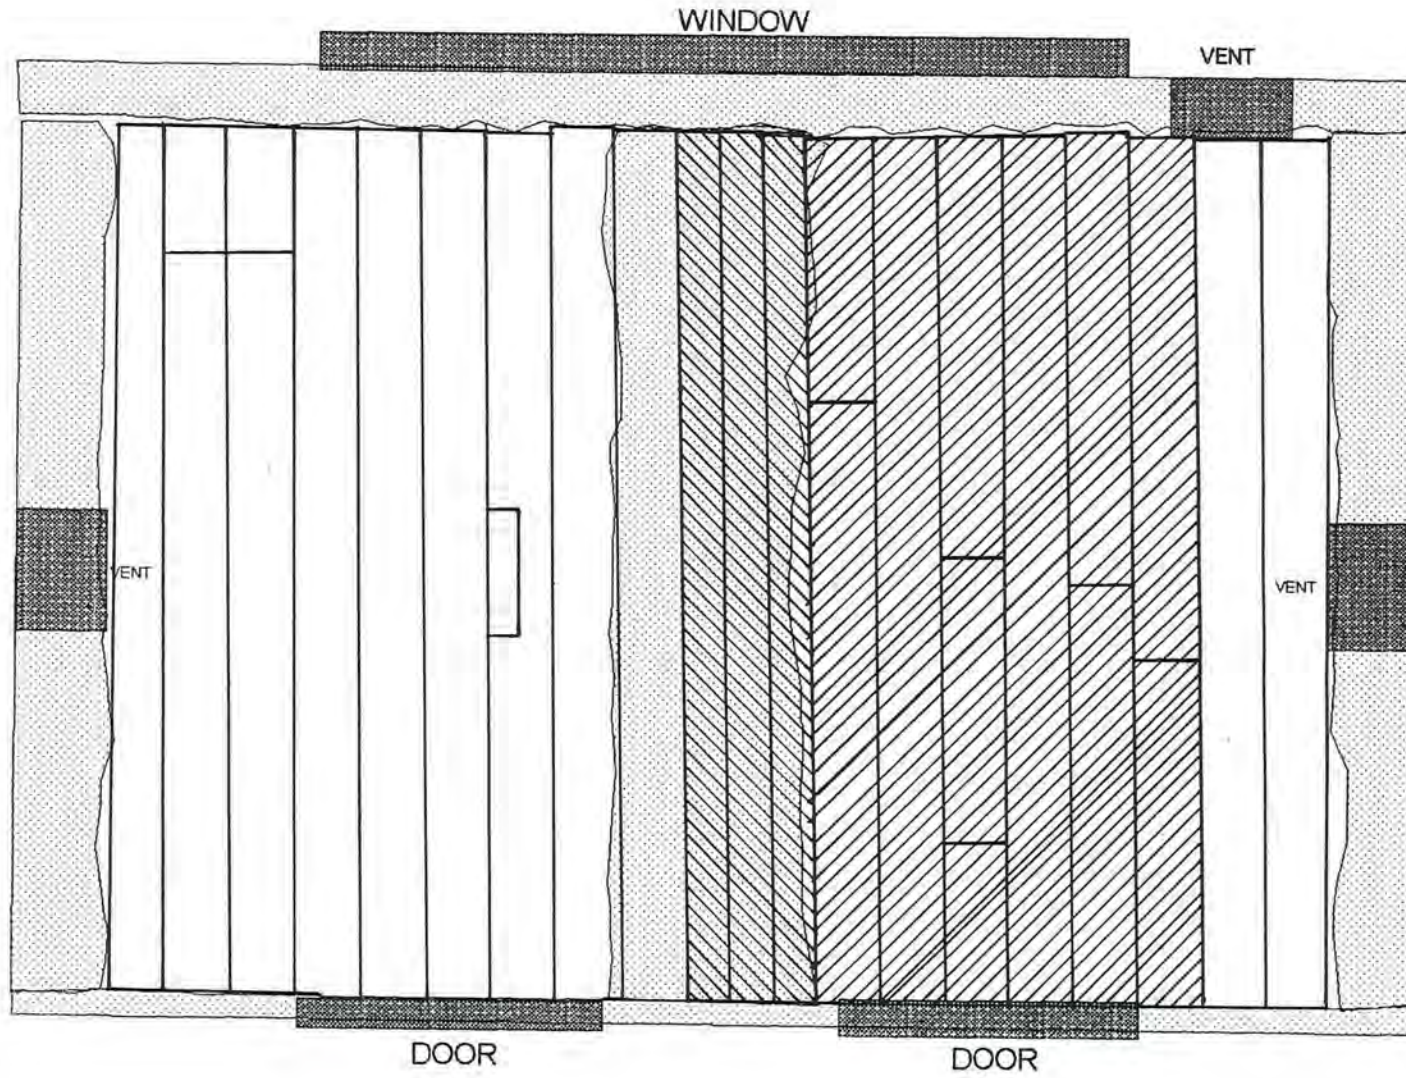
Floor boards were laid oriented east west at right angles to the joists. Three different types of floor boards fixed with three different nail types were found in A20 (Fig 4). Boards 3 to 10, 10a and 18,19 are surviving original boards 17 cm wide with no tongue and groove (Plate 5). They formed the bulk of the floorboards in A20a (to be returned to 1850s state) and the two boards nearest the north wall in A20b (to be returned to 1860s state). These two boards lay under the line of the hammock, away from the door on the line of least wear. All boards but board 3 were fixed with two cut brads in each joist and some were carved underneath where they passed over the joist to insure a level floor. Board three was fastened with later rose headed nails.

Cell A20A retained its original boards, the boards in A20B and the centre of the room have however, been replaced. Boards 12 to 17 form the bulk of the flooring for cell A20B. They are 17 cm wide with a square shaped groove on the bottom surface and a tongue and groove system for interlocking the boards (Plate 22). They were fastened with rose headed nails except for board 17 which also had one modern square headed wire nail. The type of

FIG 4. PLAN OF FLOOR BOARDS IN CELL A20.

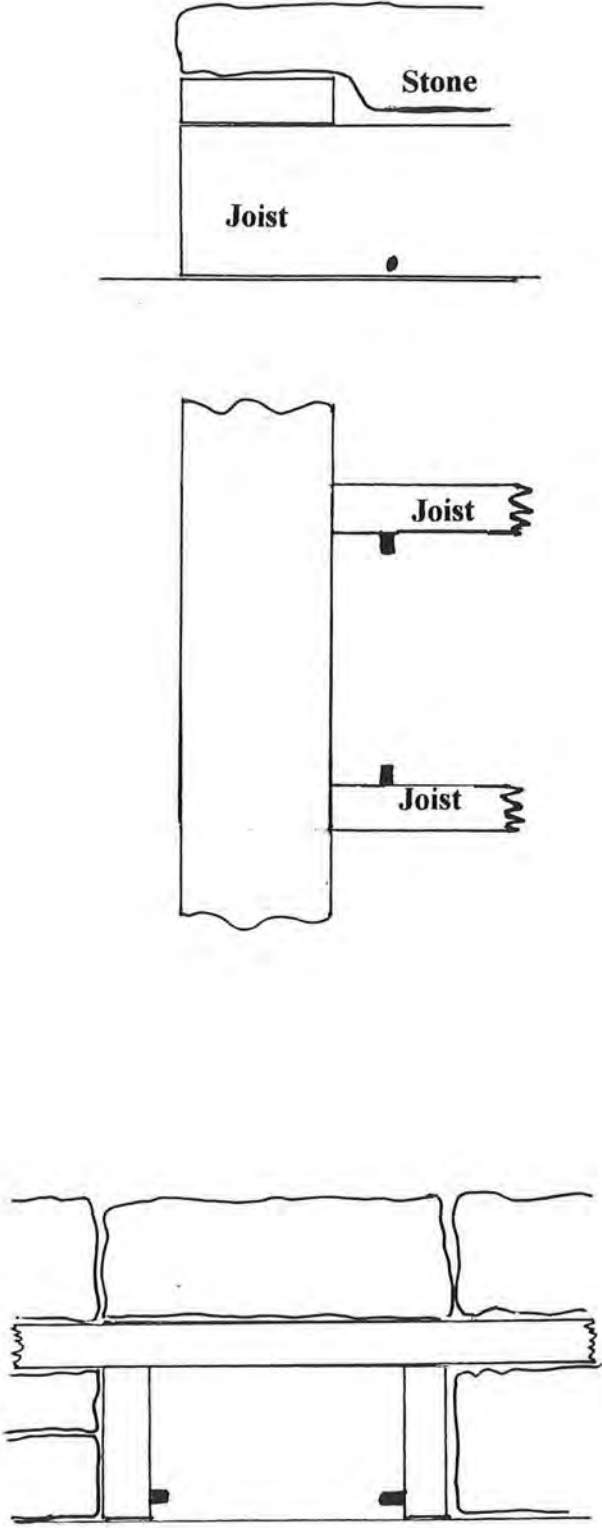
FIG 5. HYPOTHESISED CONSTRUCTION OF CEILING VENT COVER

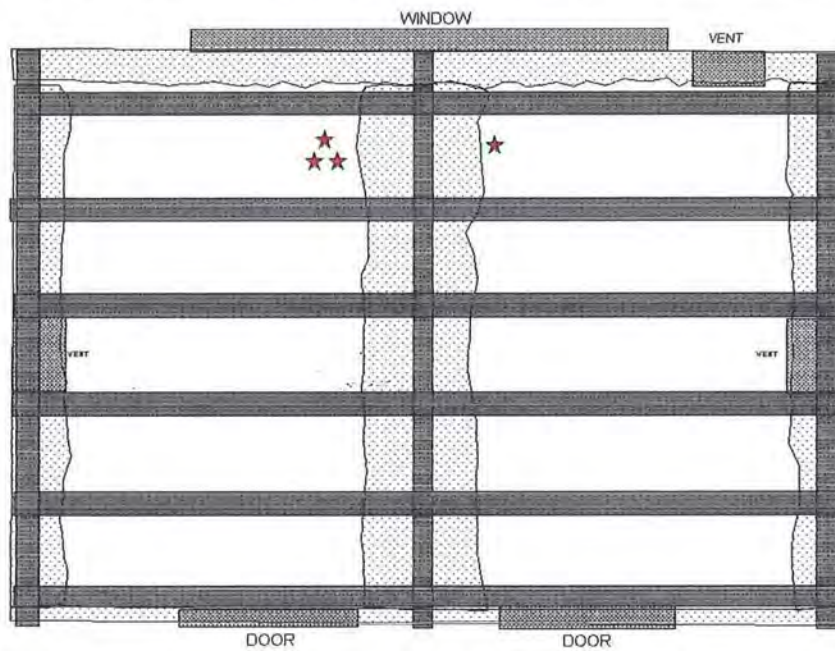
FIG. 6 LOCATION OF BONE TOOTHBRUSHES IN CELL A20

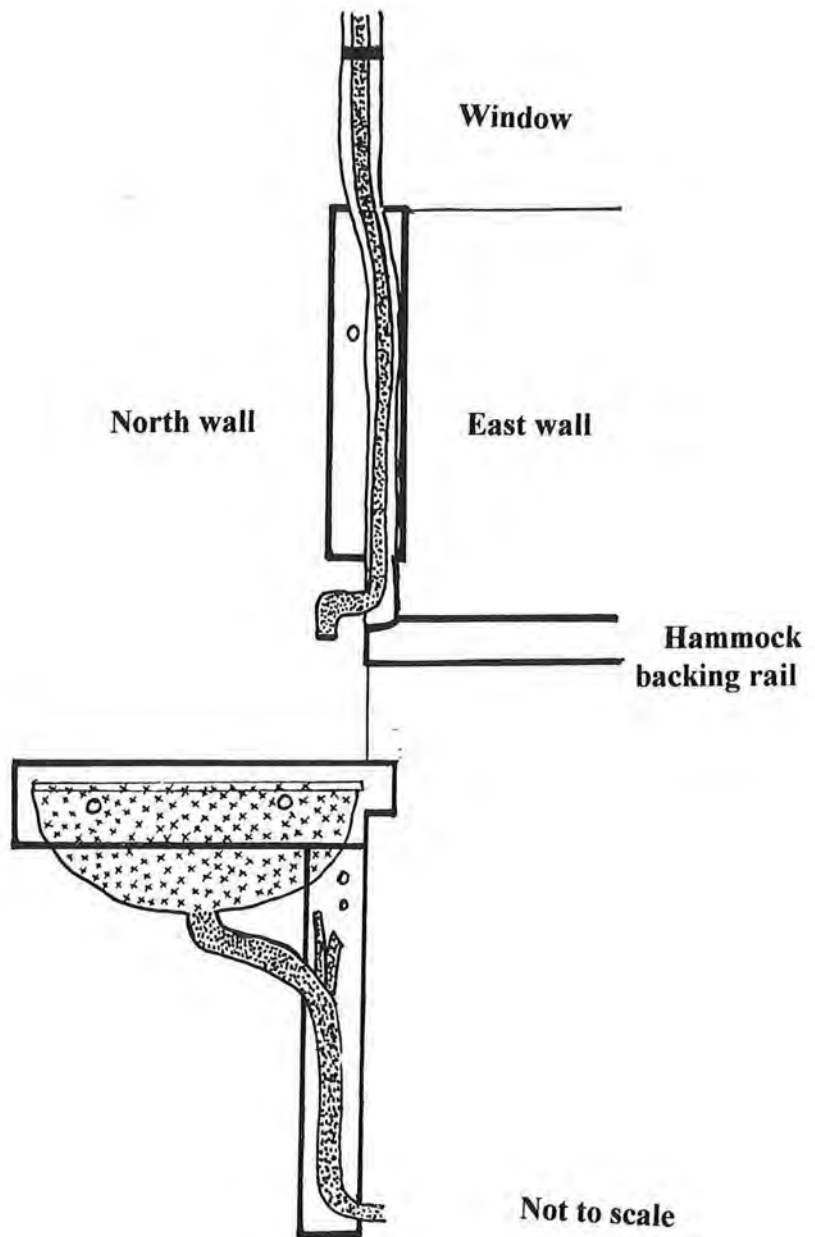
FIG 8. HYPOTHESISED CONSTRUCTION OF WASHBASIN AND PLUMBING

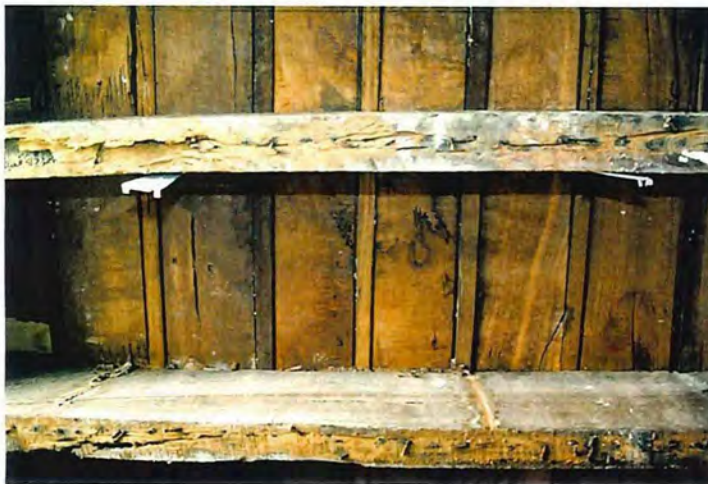
Plate 10. Joists and ceiling boards

A modern plaster-glass ceiling was removed from A20. Upon removal part of a timber picture frame was found lodged between the modern ceiling and the flooring of the cell above. Ceiling joists run at right angles to the floor joists being positioned between the external and corridor walls. A 4 by 4 cm timber batten is fixed using wrought nails to the inside face of each joist which abuts the cell side walls forming a barrier between the joist and the limestone. The walls were then built between the ceiling joists completing the walls in A20. Although not observable it is likely that bearers were laid along the external and corridor walls under the ceiling joists in a similar manner to that used for the floor joists. The floorboards of the cell above then formed the ceiling of cell A20 (Plate 10).

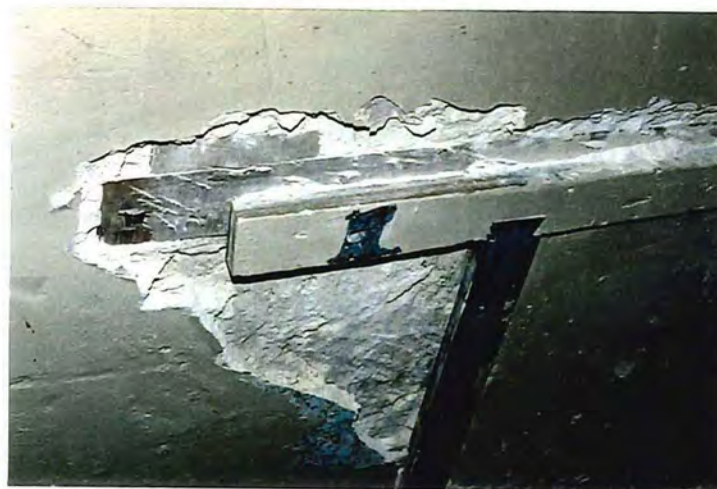
Plate 14. Table bracket, Cell B37

There is a timber stop fixed to the upright with wire nails in D38. Four small nail holes, two larger screw holes and a saw cut were found in the same position in B37. While the wire nails indicate the present stop is not an original fixture it is the only evidence for how the table leg was fixed to the table. It indicates a short leg was fixed to the table flap and

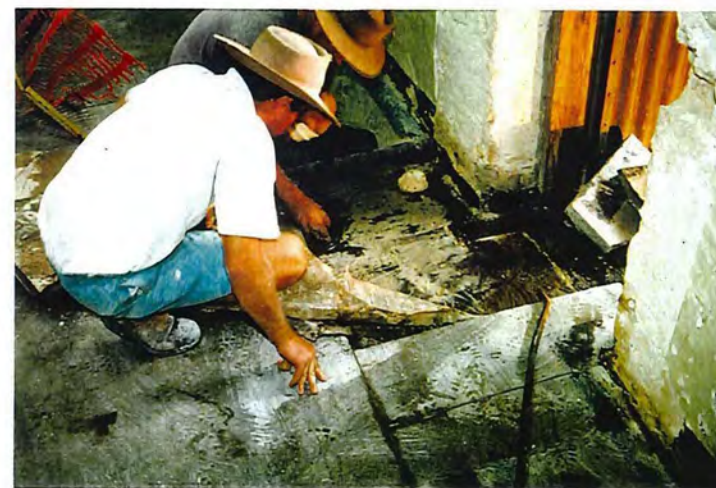
Plate 21. Corridor demonstration panel

The removal of concrete for a demonstration panel in the corridor (Plate 21) revealed the original flooring of compact Yorkshire stone flagstones. Small off cuts of this stone were found in A20a near the vent in the southern wall.

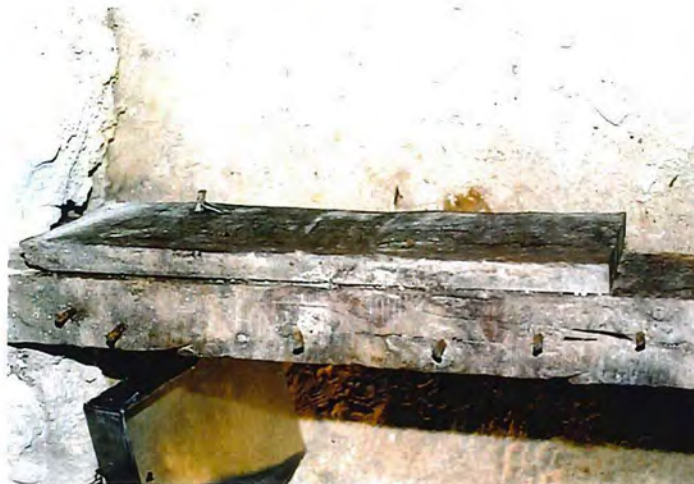
Plate 23. Joist repair

Joist 2 also showed evidence of repair in A20A having a short batten fixed to the western side of the southern end of the beam (Plate 23). The repair batten has a wrought nail protruding from it but it is fastened to joist 2 by rose headed wire nails. These are the same nails used to pin floor boards 12 to 17 and to refasten board 3. Given the temporal location of the wrought nails in A20A already discussed, this repair is likely to date from the same general period as that of board three.

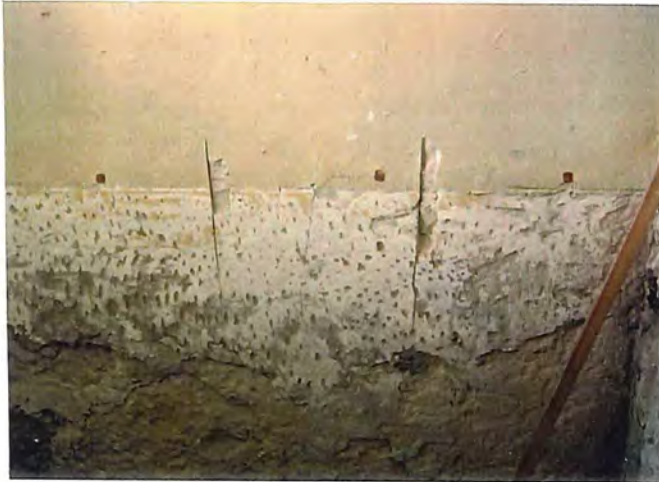
Plate 26. Hammock wear

Evidence was found in cell A21 of wear and subsequent patching on the north wall adjunct to the line of the hammock (Plate 26). A large depression with a gently curved lower edge had been worn into the limestone at the approximate position of the slung hammock. This had been patched with lime mortar and lime washed.
