Report
 on the Results of
 Archaeological monitoring of ground disturbance

**Fremantle Prison, Fremantle, Western
 Australia**
 for
**Palassis Architects &
 Fremantle Prison**

November 2005

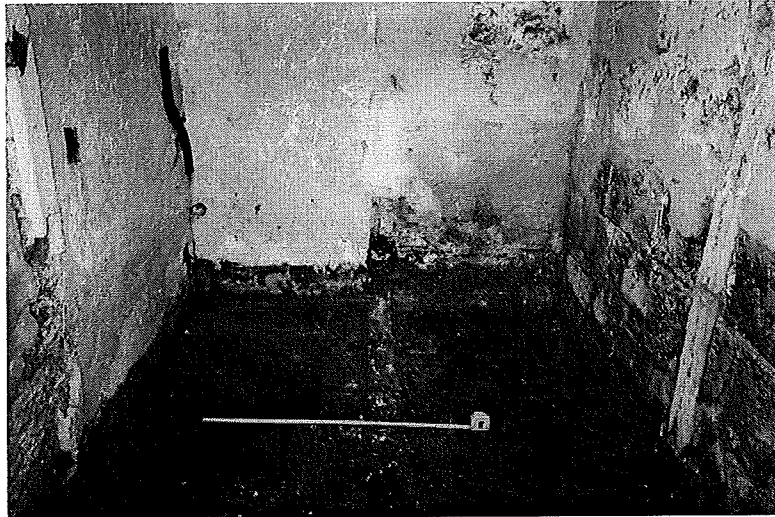
Plate 1 – concrete pad and brick (contexts 10 & 11) dividing wall at western end of trench

The recording forms (context sheets) for each context are attached in Appendix 2. A Harris matrix providing an interpretation of how the different contexts relate to each other, horizontally and vertically is shown in Appendix 1. Table 1 below provides a list of contexts identified during the excavation. In summary, beneath layers of topsoil (context 1) and demolition rubble (context 2) there were the remains of a structure in the western end. This consisted of a concrete floor with the brick base of a dividing wall and wooden thresholds (contexts 4, 9, 10 & 11) (Plate 1). This extended 3.07m from the western end, and at 1.88m wide, matched the width of the area between the walls. There was evidence of flooring (context 5) on the eastern concrete pad.

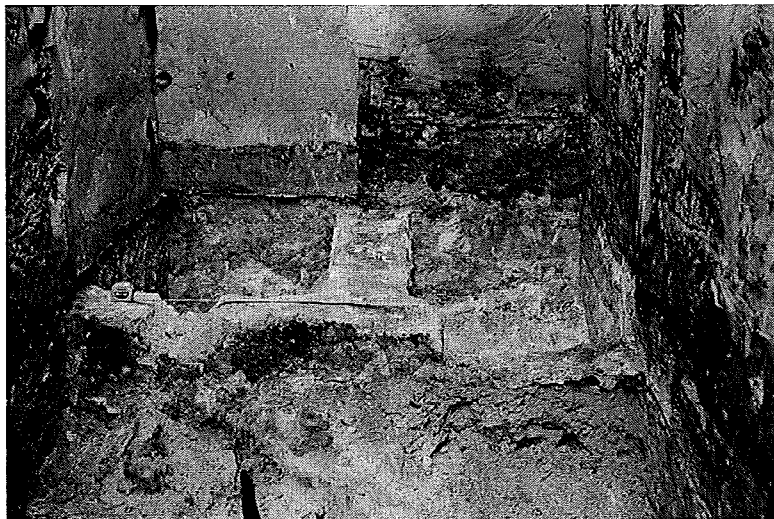
Plate 2 – Limestone wall base (context 25)

At the western end was a T-shaped wall base made of limestone cut blocks with mortar (context 25). This followed the line of the brick dividing wall and the wooden threshold that was between the two concrete pads. This wall was partially removed at the northern end, although the majority was left *in situ* (Plate 2).

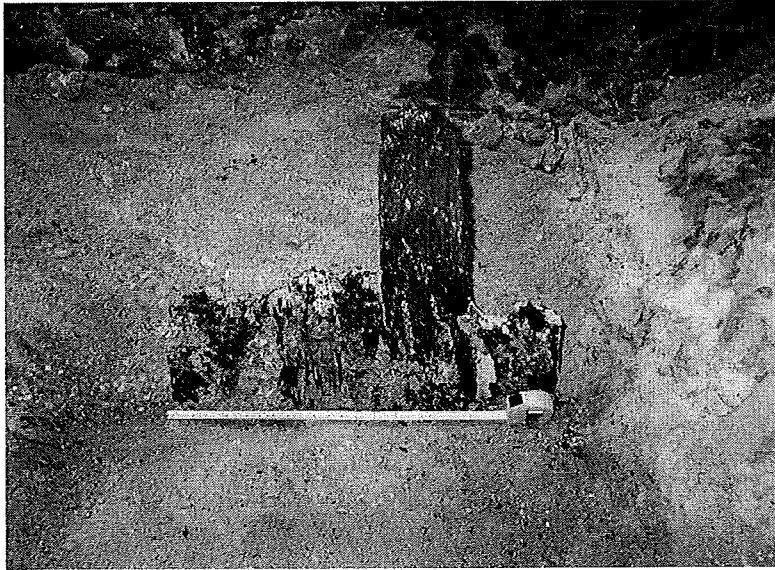
Plate 3 – Timber boards in context 17

Within this layer was a wooden artefact (Plate 3). It consisted of five vertical timber boards, each 0.12m wide, with two largely decomposed timber boards at each end. The longest was 0.60m, however the original length would have been greater. At the base of these was a timber cross beam linking them altogether. The cross beam was approximately 0.06m wide and 0.60m long. Most of the wood collapsed upon removal. Preliminary investigations suggest that the wood is She-Oak (*Casuarina* sp.), a timber commonly used for roofing in buildings during this period in Western Australia (Allia 2006, pers. com.).

Following identification of the species, the wooden artefact of joined timber boards appeared to be part of a collapsed roof. It was not *in situ*, and was part of the surrounding fill.

1. continue to monitor any further ground disturbance work at Fremantle Prison, particularly within Zone A, the area of highest archaeological significance as identified in the Archaeological Zoning Plan (Bavin 1990b).
2. consult a materials conservator to assess the wooden artefact so it can be stabilised and conserved if required.

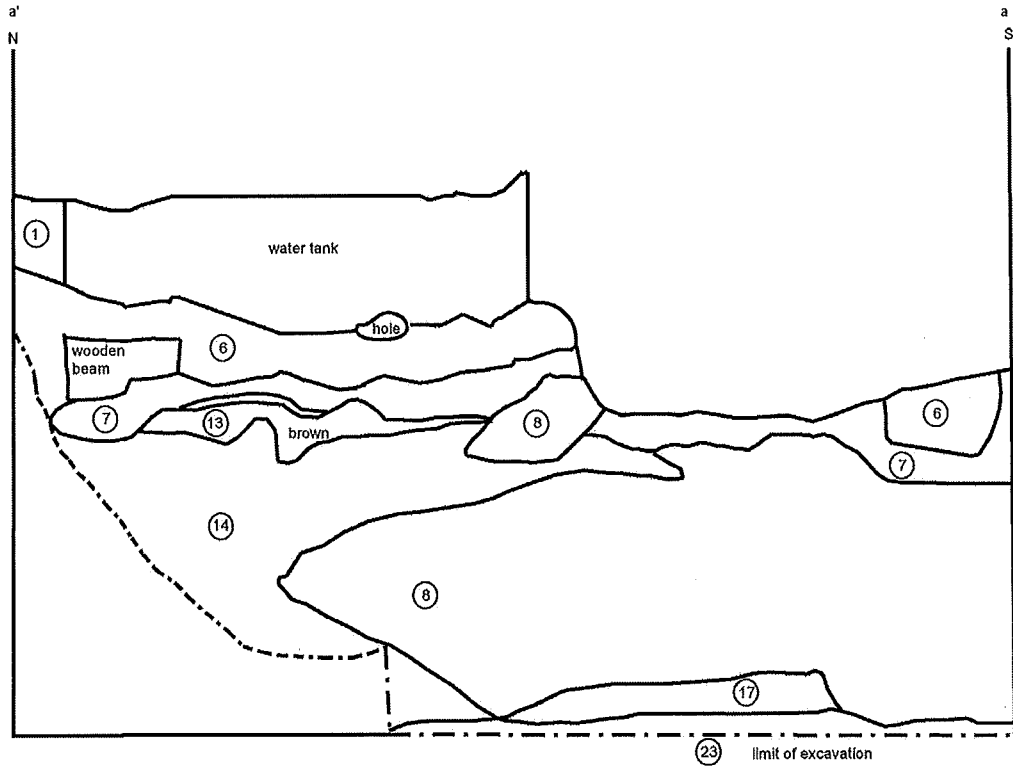
Fremantle Prison Courtyard
- Section 1

West facing section
Samantha Bolton & Annie Carson
30/08/05
