FREEMANTLE PRISON CONSERVATION
AND FUTURE USE

ARCHAEOLOGICAL ZONING PLAN
OF THE PRISON COMPOUND

L. J. BAVIN

Date: February, 1990.

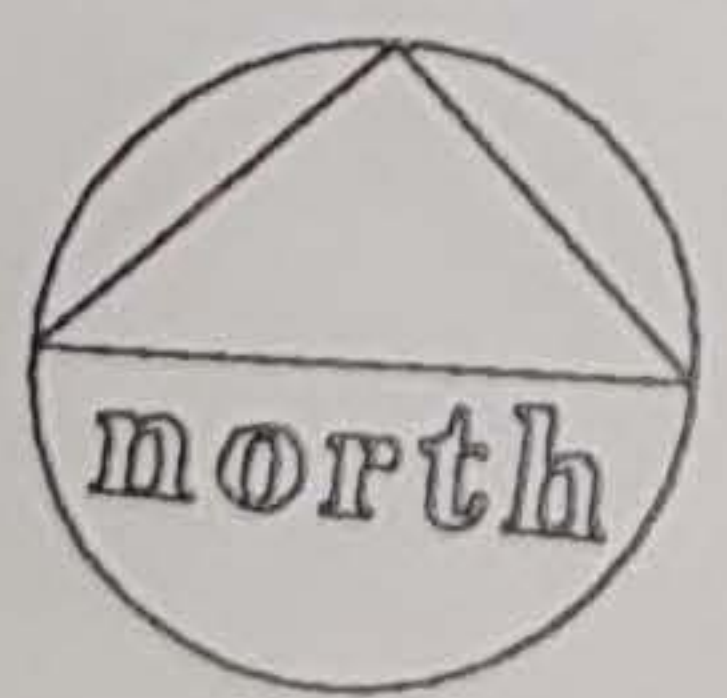
figure 2

**FREMANTLE PRISON PRECINCT
Archaeological Zoning Plan**

- ZONE A**
- ZONE B**
- ZONE C**
- FREMANTLE PRISON CONSERVATION & FUTURE USE STUDY AREA**
- ARCHAEOLOGICAL ZONING PLAN STUDY AREA**
- EXISTING STRUCTURES**
- DEMOLISHED STRUCTURES**

3.3.01. Construction began on Fremantle Prison in 1852. At present the prison walls enclose 23 substantial structures (Figure 2). Based on information presented in Chapter 2, 18 plans have been compiled to outline construction periods throughout the 19th and 20th Centuries.

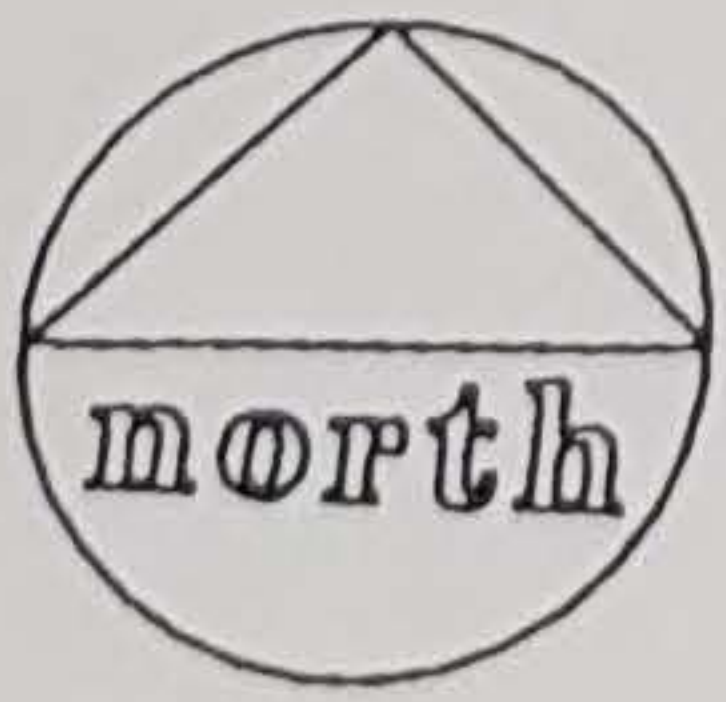
ZONE A
 DEMOLISHED STRUCTURES
-

ZONE B
 EXISTING SUB-SURFACE STRUCTURES
-

ZONE C
 EXISTING STRUCTURES
-

ZONE BOUNDARY

1.1.02. This report details a zoning plan of the Fremantle Prison compound in which areas are classified according to their archaeological sensitivity (Figure 4). The compound, as defined in this report, incorporates all areas and structures within and including the boundary walls of the prison. In addition on its western front the study area includes residential and administrative buildings and gardens bound by the top of the embankment and the garden wall (Figure 2). The Hampton Road Reserve (East) is outside the defined compound. However, construction and demolition activities in this area are included in this report (Plans 1-18). Although this report is confined to the areas defined above, the Fremantle Prison Project is also concerned with areas of archaeological potential that exist beyond the prison compound (Figure 1). Some archaeological investigations have been carried out within the Fremantle Prison Precinct external to the prison compound. Further work remains to be completed in these areas. It is recommended that areas of the Prison Precinct external to the compound be further researched and an additional zoning plan prepared. Figure 2 incorporates some zoned areas outside the compound but within the prison precinct boundaries that have been identified to date.

4.2.01. Areas zoned A in Figure 4 are suspected of containing archaeological remains in the form of building foundations, stores, amenities and services where associated artefacts are likely to be found, thematically and functionally unique structures which are of historical or archaeological research value, and other sites which may be reactivated to reinforce historical integrity of the prison. These sites have a high potential of yielding cultural material which may be used to address significant research questions. Major research questions which might be addressed concern:

4.2.02. In Zone A areas it is essential that no development activities take place before thorough archaeological investigations have been carried out. If it is found, from test excavations, that a proposed development will threaten a significant archaeological resource, it is strongly recommended that the development be re-designed to avoid that resource. The following sites have been allocated Zone A classification:

4.3.02. It is recommended that areas classified as Zone B be sufficiently archaeologically tested to locate any major remains which may necessitate re-designing development works. Development works proceeding on the basis of test excavation results should be accompanied by archaeological surveillance. During such works contracts should allow for proper salvage of remains.

4.4.01. Areas zoned C in Figure 3 would appear to have little or no potential for archaeological remains. This conclusion is based on documentary research. Zone C areas were not places of concentrated activity nor were substantial buildings constructed in these areas. However, 19th Century prison plans indicate that shallow drains dissect various areas within the compound. Contractors should be briefed on the possibility of uncovering such remains. Should archaeological remains be uncovered during the course of development works it is recommended that contractors cease work until the remains have been inspected and assessed by an archaeologist.
