**The report of an Archaeological Watching Brief
undertaken within the Female Division, West
Workshops, and The Terrace sections of
Fremantle Prison, Fremantle, Western Australia**

For YHA WA Inc.

July 2015 | Simon Colebrook and Tony Bartlett

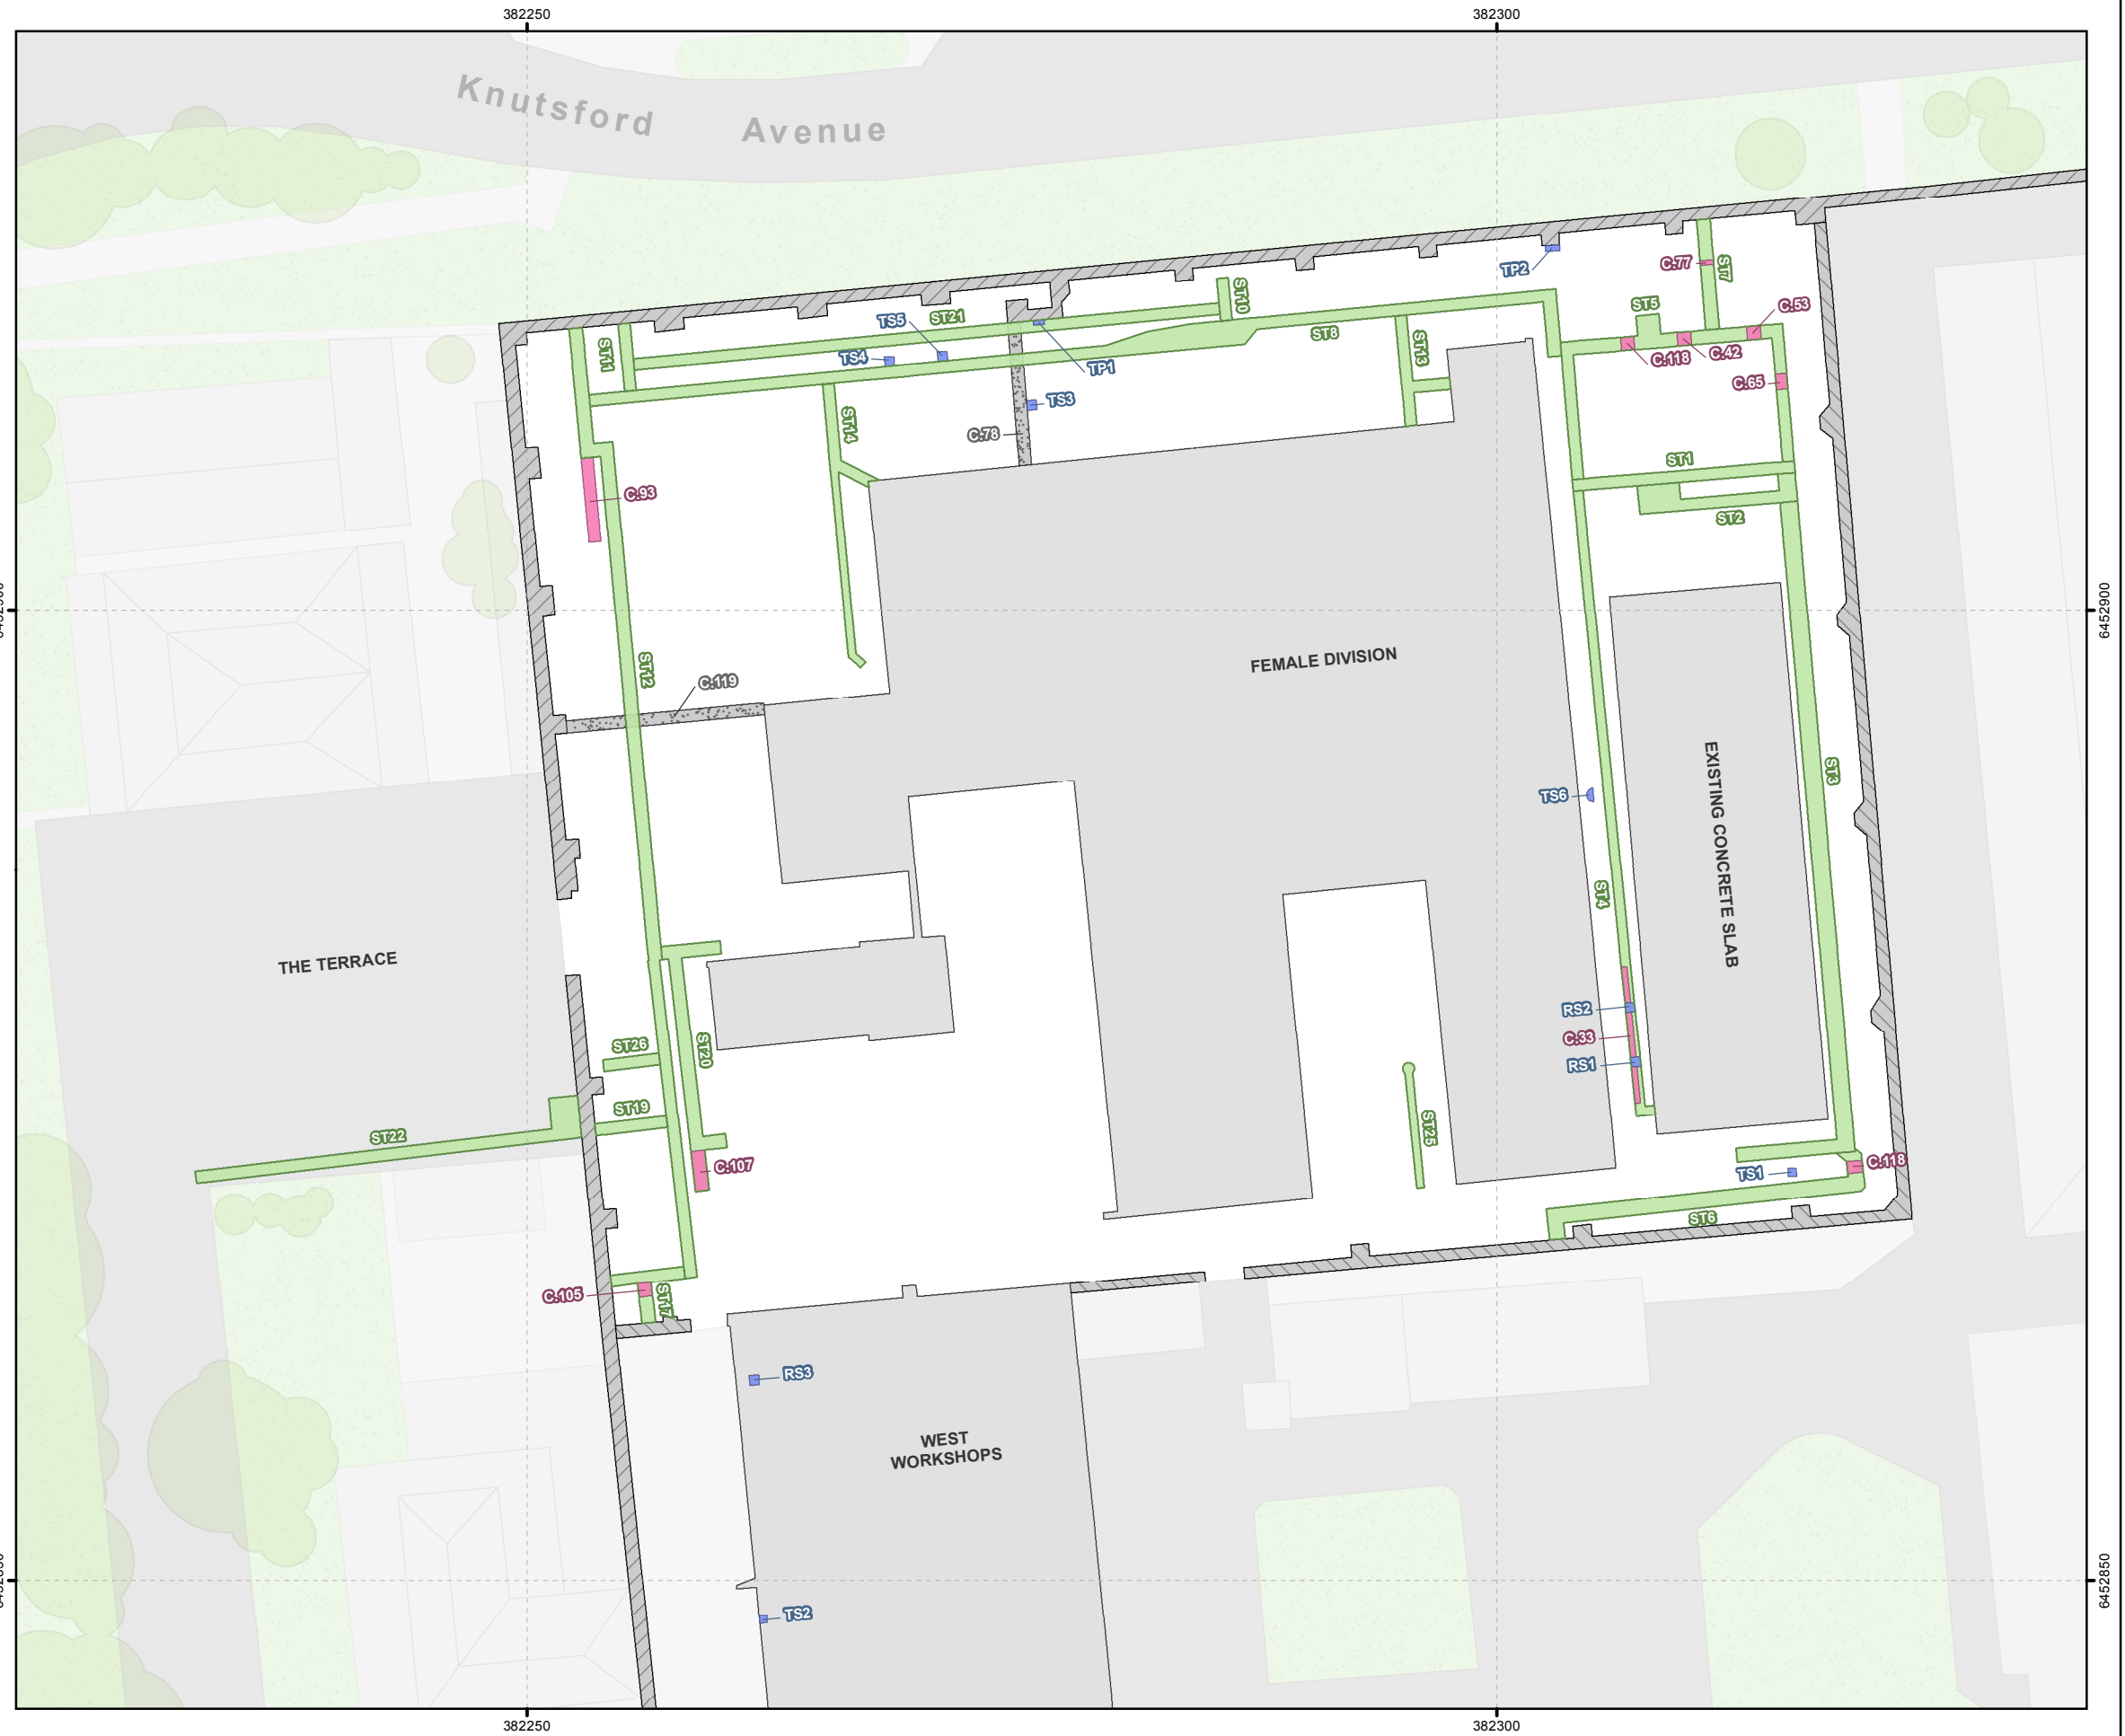
Figure 2: Fremantle Prison zoning (after Palassis Architects 2010)

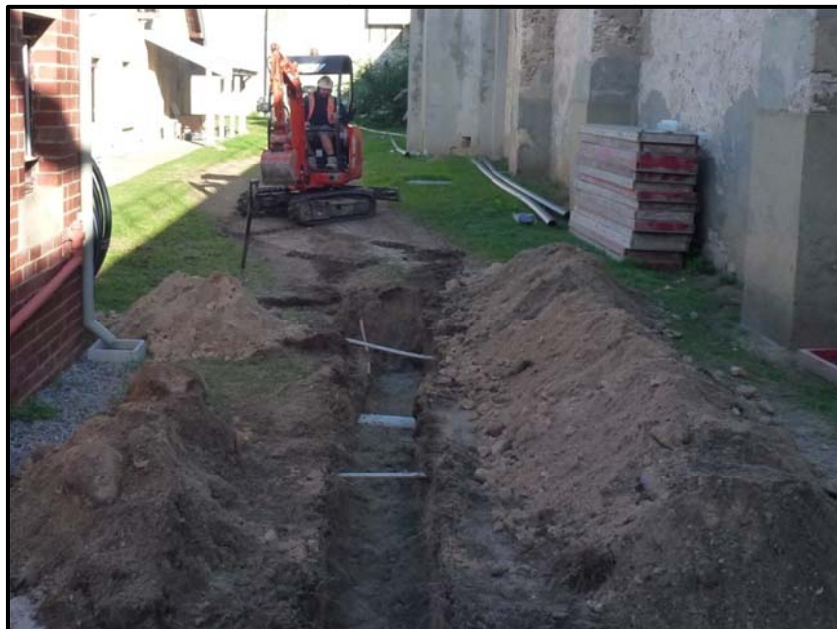
Plate 2: View of trenching works in the Northern Courtyard of the Female Division

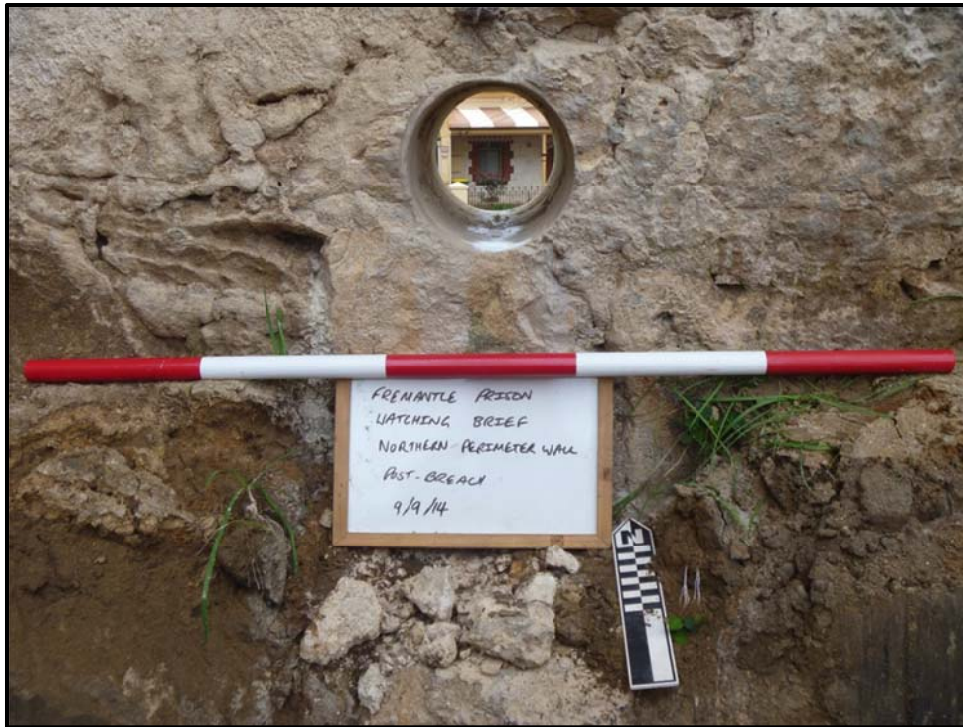
Additionally, holes for service ducts were drilled through the basal courses at two locations along the Perimeter Wall. The first was drilled through the northern Perimeter Wall at the northern extent of Trench ST12 (see Plate 3). This purpose of the first service duct was to connect the fire services system with the existing mains supply located on Knutsford Street. The second service duct was drilled through the western Perimeter Wall at the western extent of Trench ST19 (see Plate 4). The purpose of the second service duct was to connect the fire services system to a fire hydrant located on The Terrace.

Plate 3: Service duct hole in northern Perimeter Wall (Scale = 1m)

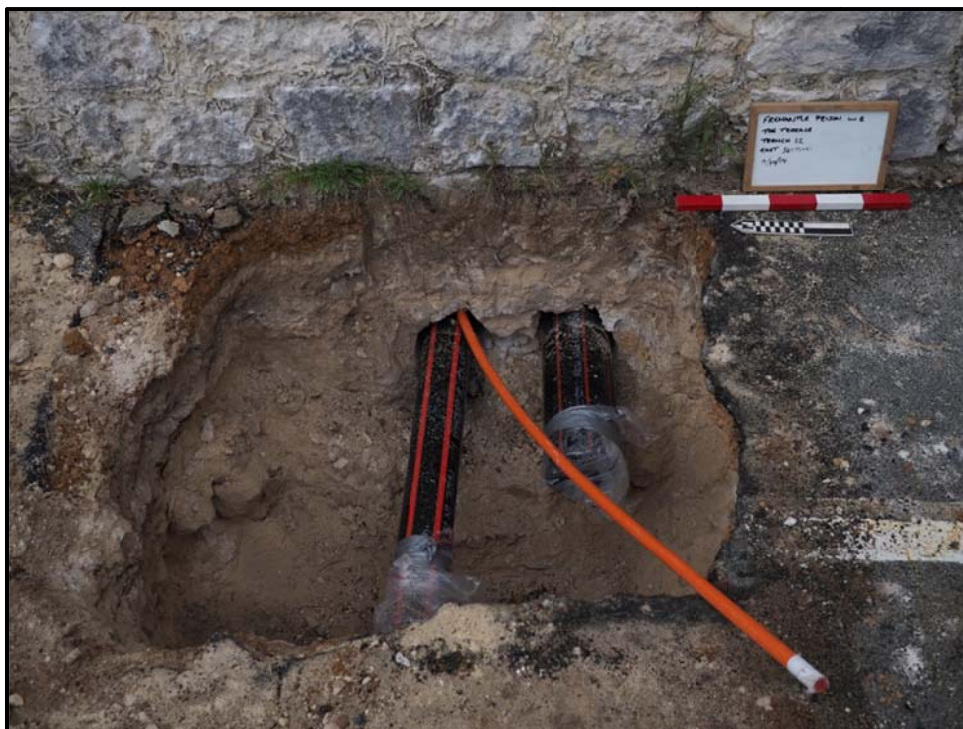
Plate 4: Service duct hole in western Perimeter Wall (Scale = 50cm)

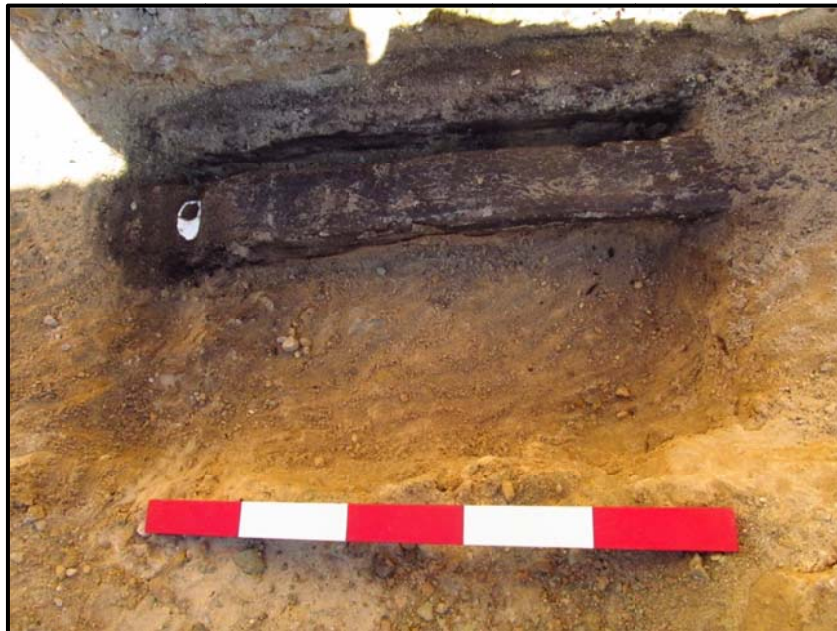
Following the investigation and recording of the electrical conduit trenching activities resumed, resulting in the removal of the feature and the excavation of the trench to a final depth of 0.70 m. Natural subsoil (C.80) was reached throughout the southern portion of the trench.

Plate 5: View of electrical feature C.33 in Trench ST4, looking west (Scale = 50 cm)

The electrical conduit (C.33) appears to date to the original Female Division construction and renovation in 1888. The orientation of the electricity conduit to the north-northwest suggests that it was once connected to a mains board located within the eastern wing of the Female Division building.

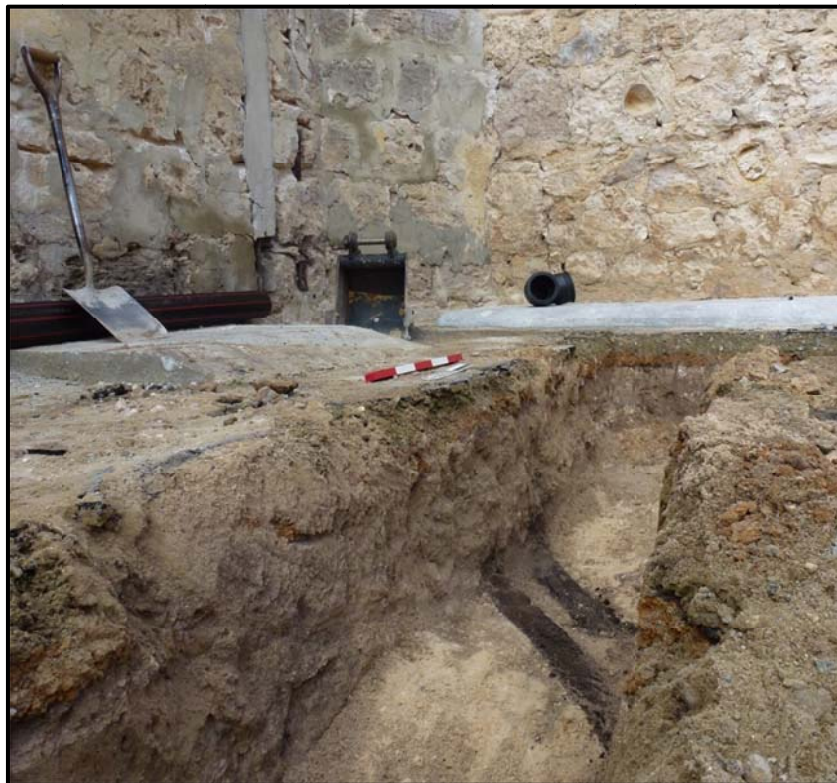
An electrical conduit (C.118) comprising side by side pairs of stacked lengths of tar coated timbers, was uncovered and recorded at the base of Trench ST6 at its eastern extent (see Figure 1 and Plate 6). The individual timbers, which measured 8 cm in width by 4 cm in thickness, housed two electrical cables fixed between each pair. The conduit was orientated obliquely (NW/SE) across the N/S aligned trench. The total length of the conduit exposed in the trench was 0.70 m.

Plate 6: View of electrical feature C.118 in Trench ST6, looking southeast (Scale = 50 cm)

The orientation of the electricity conduit aligns with a corroded iron bracket located on the eastern wall in the southeast corner of the Eastern Courtyard area. A modern floodlight is present above this bracket and it is possible that a previous light (since removed) was once attached to the bracket and connected to the electricity conduit. Furthermore, the electricity conduit is oriented northwest toward a mains board located within the eastern wing of the Female Division building.

This electrical conduit (C.118) is identical to that recorded (C.33) in Trench ST4 and would also appear to date to the original Female Division construction and renovation in 1888.

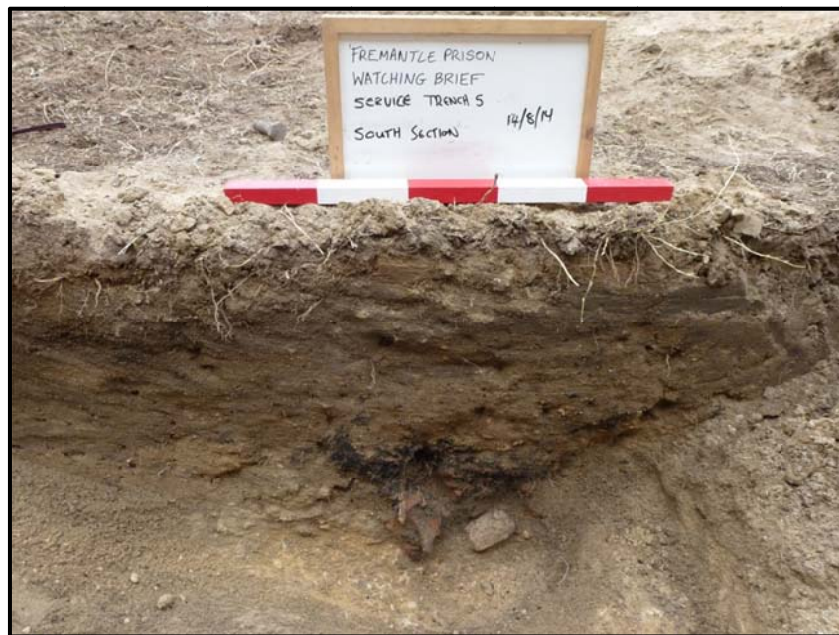
An occupational debris pit (C.42) was revealed and recorded near the centre of Trench ST5 within the southern baulk (see Figure 1). The pit cuts through the natural subsoil and was sealed by layer C.45 (see Plate 7). The pit was truncated by the trenching works and had a maximum exposed width of 0.40 m (E/W) and depth of 0.17 m. It contained a single fill (C.41) comprised of loosely compacted, dark greyish brown sandy loam with charcoal flecks and chunks. A number of finds were recovered from this context (see Appendix 8). The cut (C.42) was v-shaped in profile with straight sides and a pointed base.

Plate 7: View of pit C.42 in Trench ST5, looking south (Scale = 50 cm)

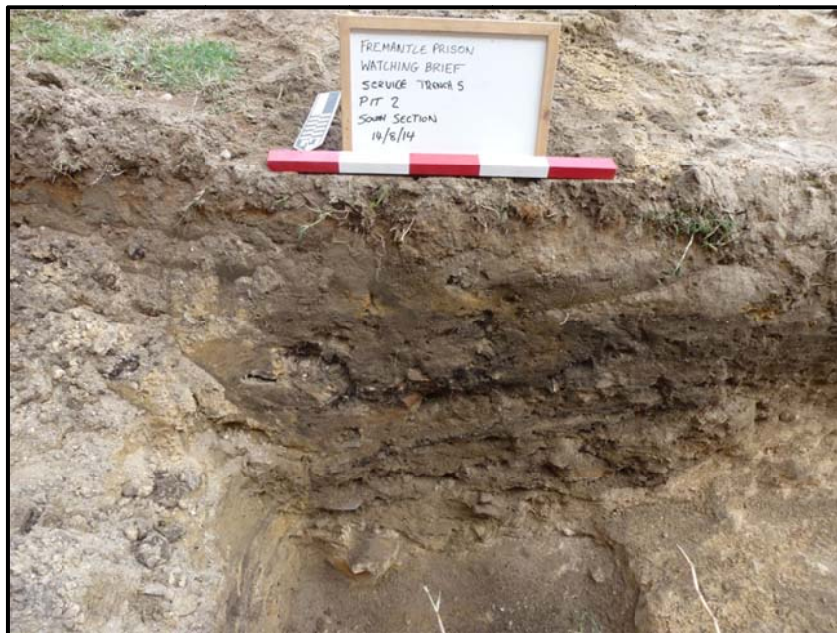
An occupational debris pit (C.53) was revealed and recorded within both the northern and southern baulks of Trench ST5 near its eastern extent (see Figure 1). The pit cuts through layer C.45 and the natural subsoil (C.80) and was sealed by layer C.44 (see Plate 8). The pit was truncated by the trenching works and had a maximum exposed width of 1.13 m (E/W) and a depth of 0.5 m. A total of five fills (C.48, C. 49, C.50, C.51 and C.52) were recorded within the pit. The basal fill (C.52) comprised loosely compacted, dark greyish brown fine grained sand with a maximum depth of 0.11 m. Fill C.52 contained a number of animal bones (see Appendix 8). The secondary fill (C.51) comprised moderately compacted, dark blackish brown fine grained sand. Fill C.51 contained occasional charcoal chunks and small pieces of decayed wood and frequent animal bone (see Appendix 8). The third fill (C.50) overlay C.51, measured 0.08 m in depth and comprised well compacted, orangish brown fine sand. The fourth fill (C.49) measured 0.10 m in depth and comprised loosely compacted, dark brownish black sand. This fill contained frequent large chunks of charcoal and occasional pieces of decayed and partially burnt undiagnostic wood, as well as a number of animal bones. The final fill (C.48) comprised moderately compact brownish grey coarse sand with occasional charcoal flecks. The cut (C.53) was u-shaped in profile with gently sloping sides and a flat base.

Plate 8: View of pit C.53 in Trench ST5, looking south (Scale = 50 cm)

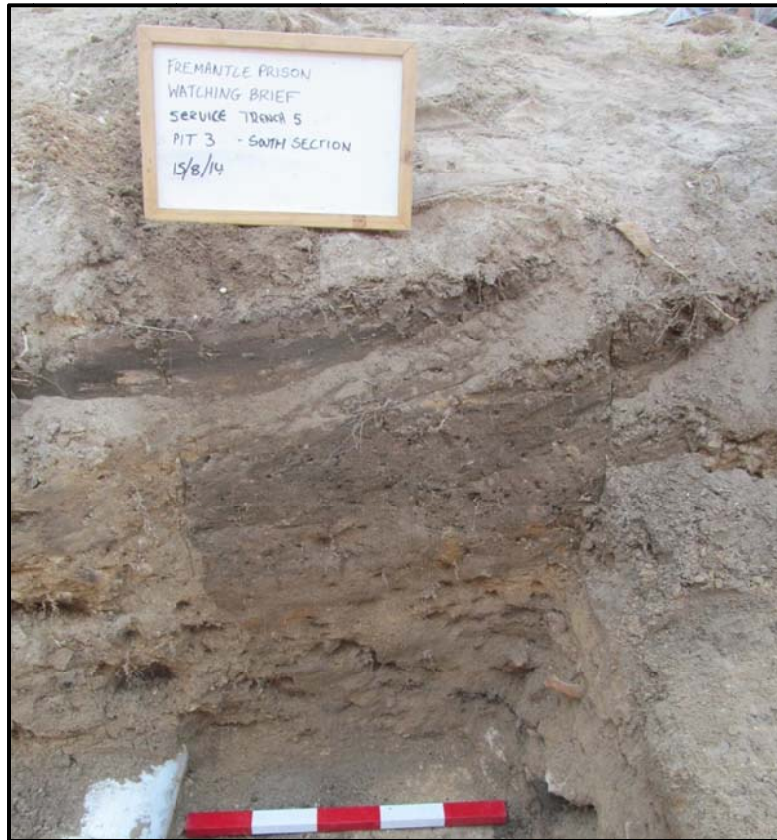
An occupational debris pit (C.62) was revealed and recorded in both the northern and southern baulks of Trench ST5, 3.0 m from its western extent (see Figure 1). The pit cuts through layer C.45 and is sealed by C.44 (see Plate 9). The pit was truncated by the trenching works which revealed disturbance caused by the installation of modern water services. These water services had resulted in the removal of the eastern half of the pit and the insertion of a large, white plastic storm water pipe (C.117), which was subsequently backfilled with mottled, moderately compacted, brownish grey sand (C.116). As a result of this disturbance, the maximum exposed width (E/W) and depth of the pit was 0.6 m and 0.45 m respectively. A total of two fills (C.63 and C.64) were recorded within the pit. The basal fill (C.64) comprised loosely compacted, brownish grey fine grained sand which contained a number of animal bones (see Appendix 8). The secondary fill (C.63) comprised moderately compacted, brownish orange fine grained sand and also contained animal bone.

Plate 9: View of pit C.62 in Trench ST5, looking south (Scale = 50 cm)

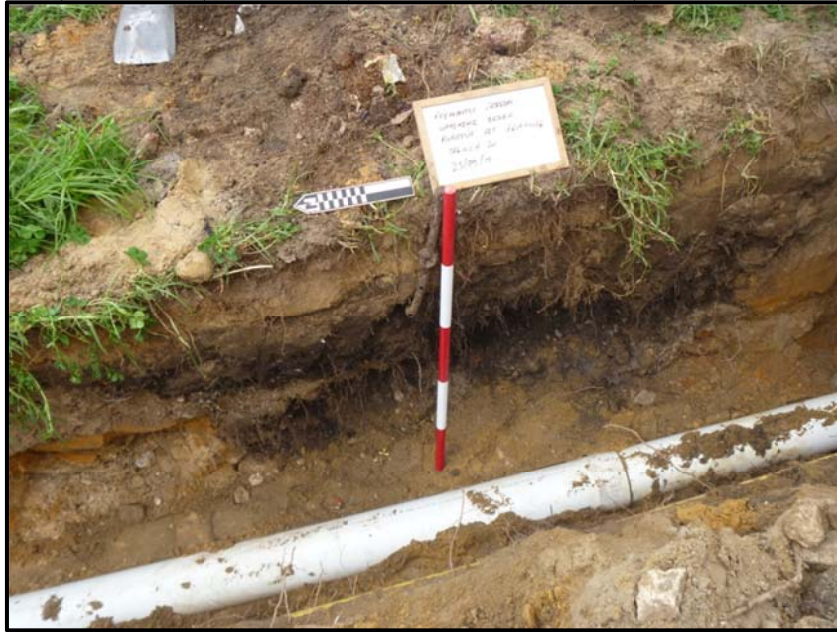
An occupational debris pit (C.62) was revealed and recorded within the eastern baulk of Trench ST20, near its southern extent (see Figure 1). The pit cuts through layers C.103 and C.12 and is sealed by the current topsoil (C.81). The pit was truncated by trenching works and had a maximum exposed width of 2.0 m (N/S) and a maximum exposed depth of 0.90 m (see Plate 10). A single fill (C.108) was recorded within the pit and comprised loosely compacted, dark blackish brown sandy loam. The fill contained a large quantity of artefacts datable to the 20th century (see Appendix 8). The cut (C.107) of the pit had a sharp break of slope top, sloping sides, a sharp break of slope base and a flat base.

Plate 10: View of pit C.107 in Trench ST20, looking east (Scale = 1 m)

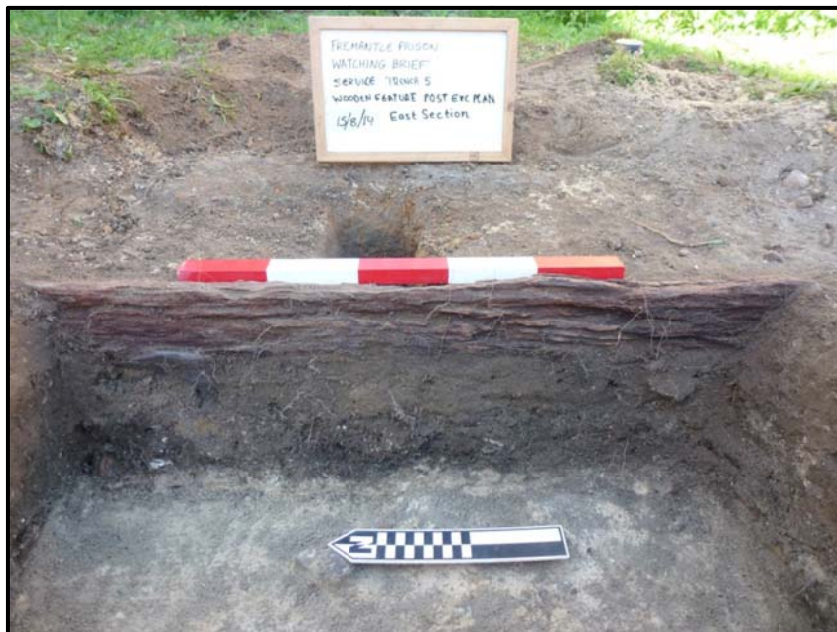
A wooden feature (C.65) was and recorded within the eastern baulk of the north/south aligned section of Trench ST5, approximately 2.50 m southeast of pit C.53 (see Figure 1). The feature consisted of a length of timber (C.65) set on edge that measured 0.04 m thick by 0.08 m wide and had a maximum exposed length of 1.0 m (see Plate 11).

Plate 11: View of wooden feature C.65 in Trench ST5, looking east (Scale = 50 cm)

The timber was inserted into, and partially overlay a 0.26 m deep layer (C.45) of loosely compacted, greyish brown sandy loam with occasional small limestone inclusions. The layer C.45 also contained a thin lens of charcoal and organic rich material at the base. This deposit (C.45) extended on either side (east and west) of the timber and overlay natural subsoil (C.80). The layer C.45 to the east of the timber was reduced by 0.06 m in height and was sealed by a layer (C.57) of highly compacted, reddish orange clay. Layers C.45 and C.57, as well as the wooden feature, were subsequently overlain by the current topsoil (C.81) extant throughout the Eastern Courtyard area.

The wooden feature (C.65) recorded in Trench ST5 would appear to represent a retaining feature acting as a boundary between layer C.45 and the clay surface C.57. A similar feature was recorded in Trench ST7. The clay surface (C.57) was also recorded in Trenches ST3, ST4, ST6 and ST7 throughout the Eastern Courtyard area.

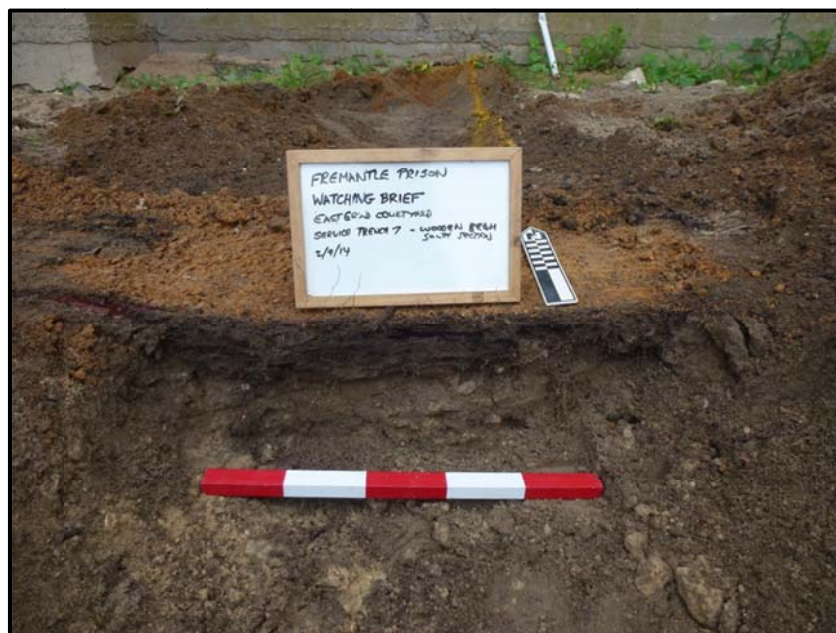
The wooden feature (C.77) was partially revealed and extended into both the eastern and western baulks of the trench (see Plate 12). It consisted of a length of timber that measured 0.04 m in thickness by 0.08 m in width and had a maximum exposed length of 0.70 m. This timber was inserted into, and partially overlay the layer C.45 which extended on either side. The layer C.45 to the north of the timber was reduced by 0.06 m in height and was sealed by the clay layer C.57. Both the wooden feature (C.77) and layer C.45 were overlain by the current topsoil (C.81) extant throughout the Eastern Courtyard area.

Plate 12: View of wooden feature C.77 in Trench ST7, looking north (Scale = 50 cm)

The wooden feature (C.77) recorded in Trench ST7 would appear to represent a retaining feature acting as a boundary between layer C.45 and the clay surface C.57, similar to the wooden feature (C.65) recorded in Trench ST5.

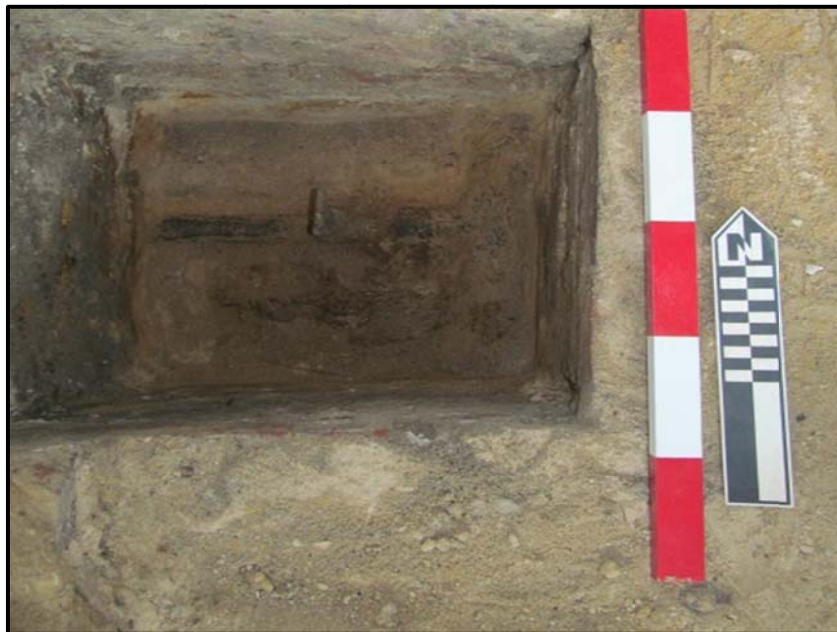
The feature was determined to be an inspection chamber used to access a copper pipe and tap located at its base (see Plate 13), which is believed to date to the construction of the West Workshops in 1900-1901. The chamber was capped by a large limestone slab that was surrounded by, and contemporaneous with, a layer of loosely compact mid-orange coarse grained sand (C.17) which contained sub-angular limestone and slate fragment inclusions. This was sealed by a 0.08 m deep layer of poured concrete (C.15) which was overlain by a 0.08 m thick concrete slab (C.14) which formed the extant ground surface.

The chamber was rectangular in plan and measured 0.50 m (E/W) by 0.35 m (N/S) by 0.60m in depth and contained a single fill (C.40) of mottled, loosely compacted brownish grey fine grained silty sand. Natural subsoil (C.80) was revealed at the base of the feature.

Plate 13: View of brick feature C.37 in Sondage RS3, looking north (Scale = 50 cm)

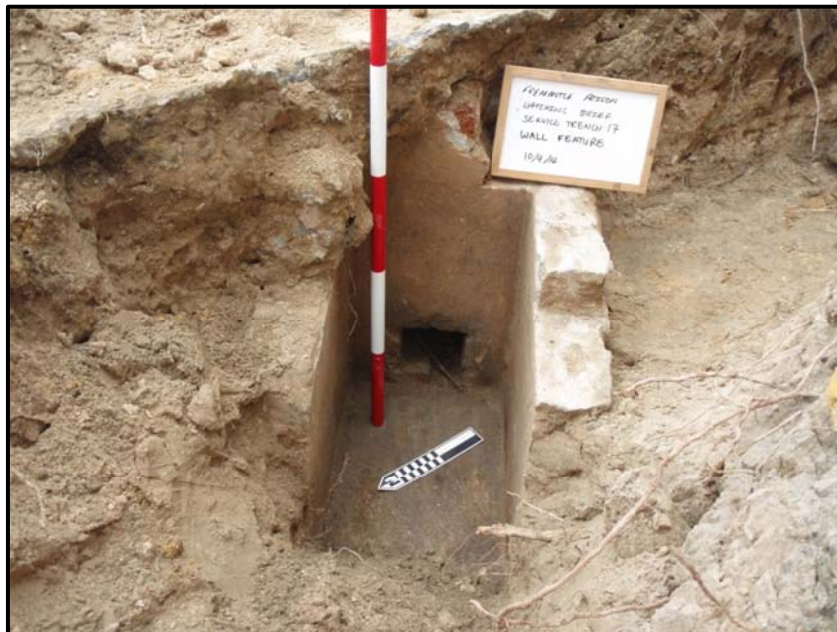
A brick-built feature (C.105) overlain by three layers (C.127, C.128 and C.129) was revealed and recorded within Trench ST17 (see Figure 1) and has been interpreted as a barbecue (see **Discussion** below). The rectangular feature comprised three walls of red brick construction that was open to the northwest and had a concrete base. It measured 0.60 m in length (NW/SE), 0.55 m in width (NE/SW) and 0.69 m in height (see Plate 14). The brick construct was entirely finished in a cement render, and the lower levels of the internal walls and the base showed evidence of a past fire event or events.

A rectangular aperture was present near the base of the feature within the back wall, revealing a channel extending southeast for a further 0.70 m. This feature was overlain by a 0.30 m deep layer (C.127) of mottled, moderately compact, yellowish grey fine grained sand and included large sub-rounded limestone and red brick fragments. A layer of poured concrete (C.128), 0.10 m in depth overlay C.127 and this in turn was capped by three large concrete slabs (C.129) which formed the ground surface level at the time of the groundworks.

Plate 14: View of brick feature C.105 in Trench ST17, looking southeast (Scale = 1 m)

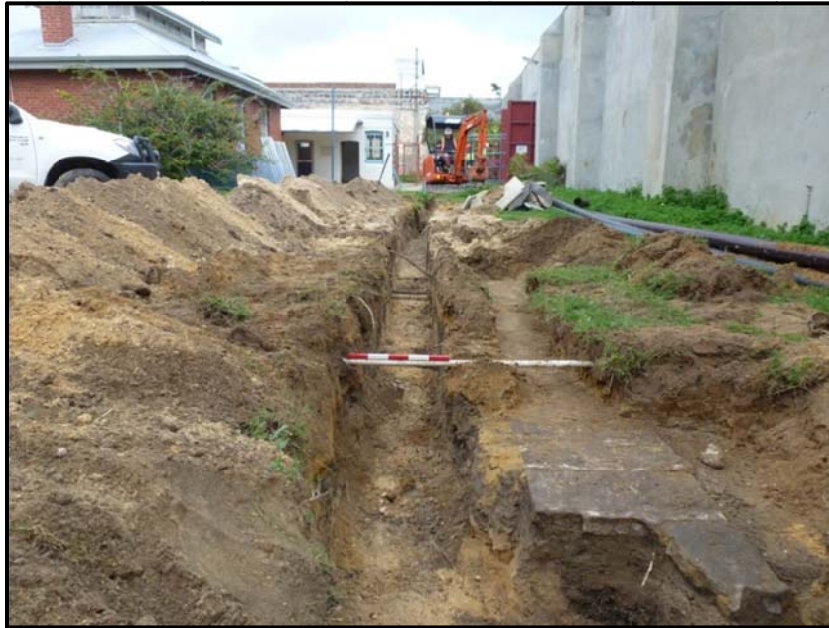
During trenching activities in the northwest corner of the Female Division courtyard a flagstone path (C.93) was revealed and recorded in Trench ST12 (see Figure 1). The trench was subsequently realigned to avoid the feature (see Plate 15).

Plate 15: View of realignment of Trench ST12 (note flagstone path C.93), looking south (Scale = 50 cm)

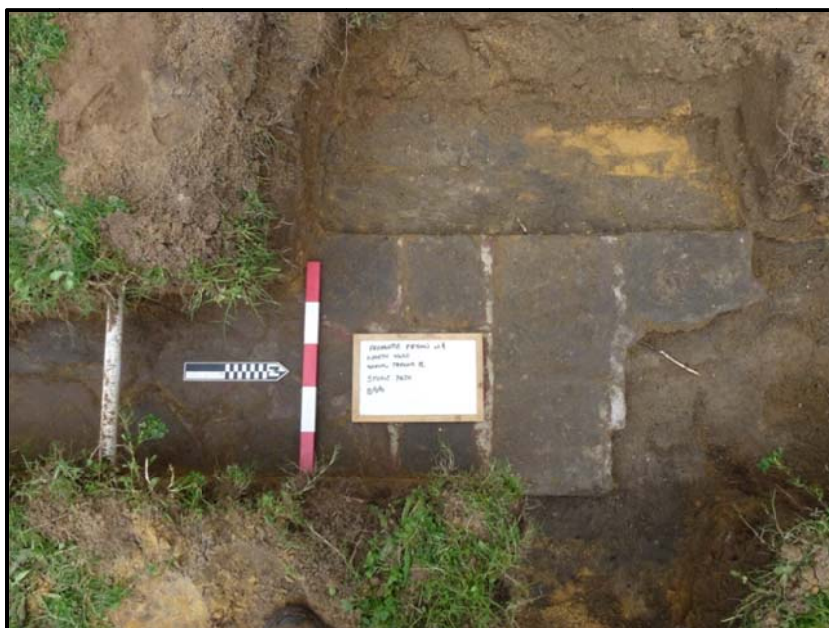
The path is 0.60 m wide (E-W), with a maximum length of 4.20 m (N-S) and consists of a layer of cut limestone flagstones set in a concrete mortar (see Plate 16). The flagstones have average dimensions of 0.30 m by 0.60 m by 0.07 m.

Plate 16: View of flagstone path C.93 revealed in Trench ST12 (Scale = 50 cm)
